Home Inspection Report

Client: Jane Doe
Property: 1945 Inspection Way Home Town NY 12306
Email: janeedoe1111@gmail.com
Inspection Date: 8/28/18

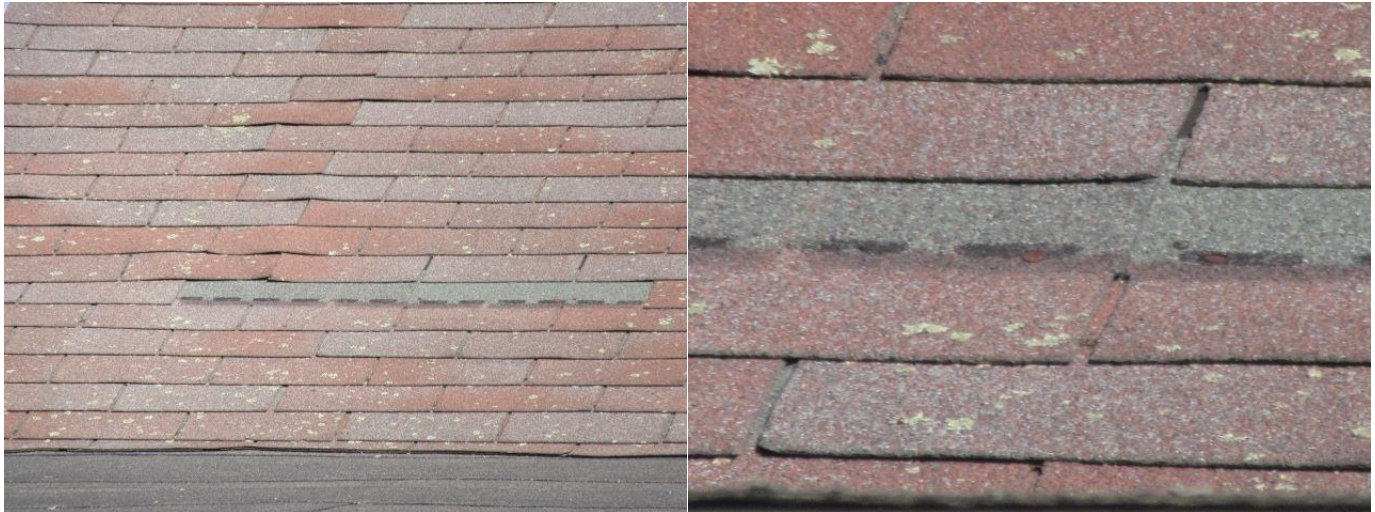
Observed missing shingles from roof. This can cause rain water to penetrate roof covering. Recommend qualified contractor repair.

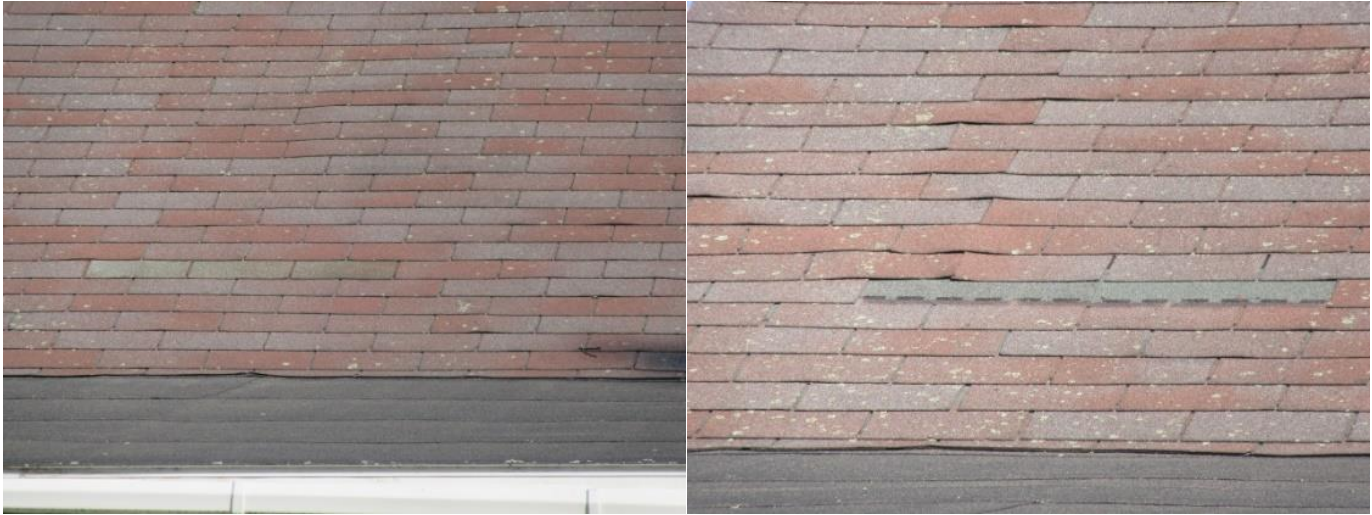
Observed lifting of shingles. This does not appear to affect the function of the roof covering. However, lifting of shingles can be caused by high temperatures in the attic space below. Excessive heat in the attic can shorten the life of asphalt shingle roof coverings. Lifted shingles are also more likely to suffer from wind damage. Recommend monitoring roof covering for loose or lifting shingles going forward.

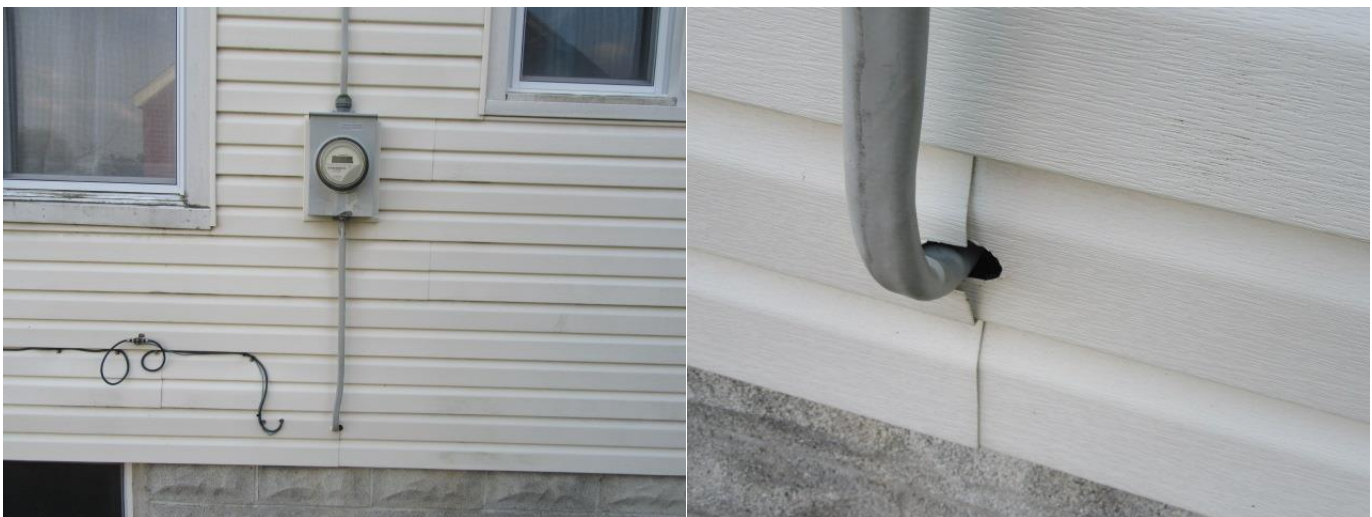
+ No caulking around entry point for service entry to main panel. This allows water to travel to main panel potentially leading to a fire or shock hazard. Recommend repair as necessary to prevent moisture penetration.

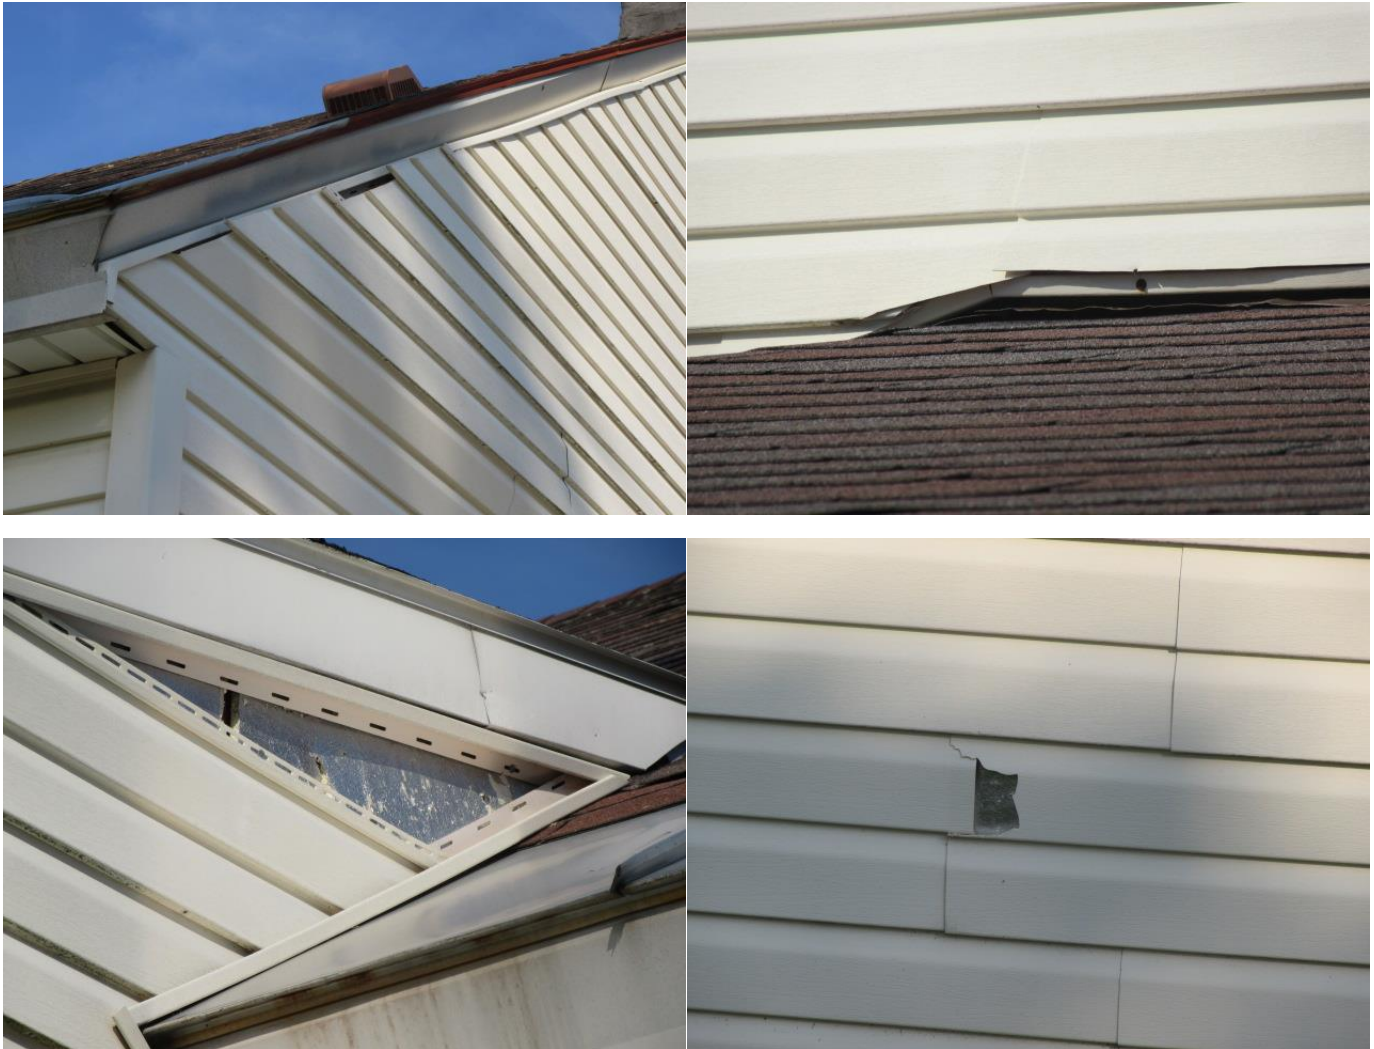
Observed loose siding panels that have pulled away from the exterior wall. This can allow rain to penetrate the wall and is susceptible to wind damage. Also observed a missing section of siding and other small areas of damage to the siding and trim that can allow water to penetrate the wall. Recommend qualified contractor repair.

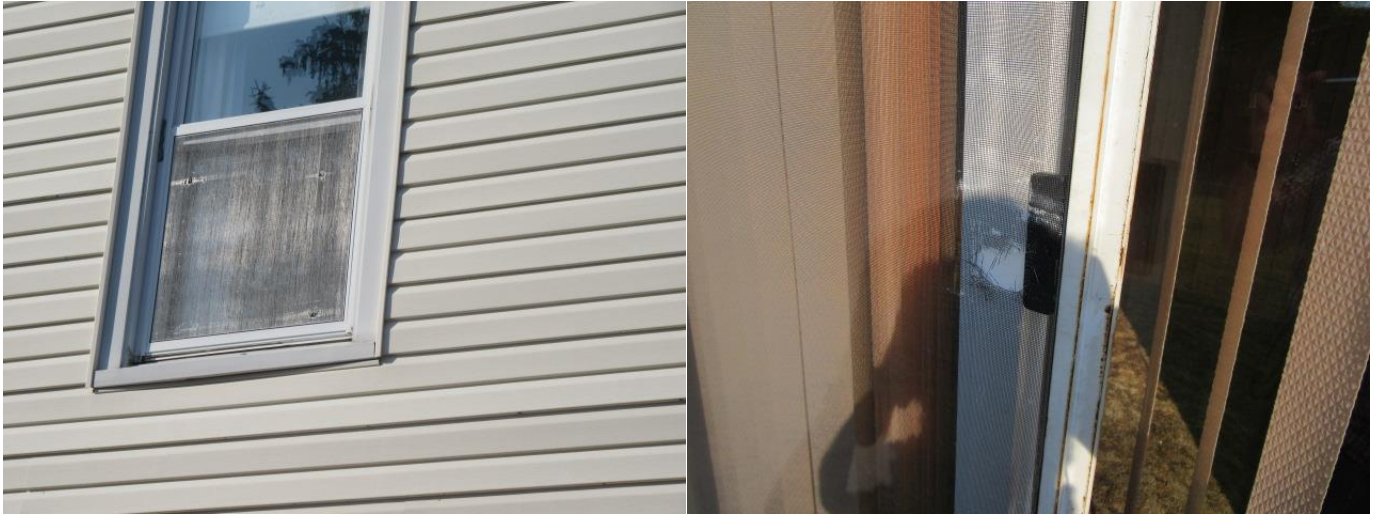
Observed multiple windows and doors with tears in the screens. Recommend qualified person repair to keep bugs out when windows are open.

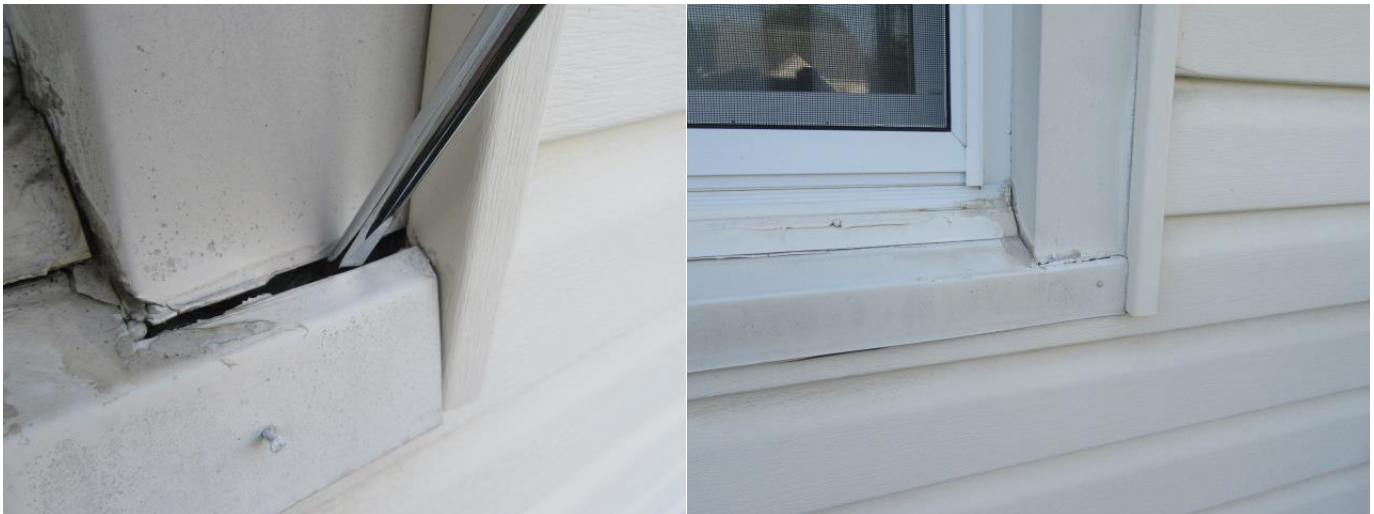
Observed gaps in trim and window wrap around windows. Observed a small amount of wood rot of window seal where gap was present. Recommend qualified person seal all gaps to prevent further water damage.

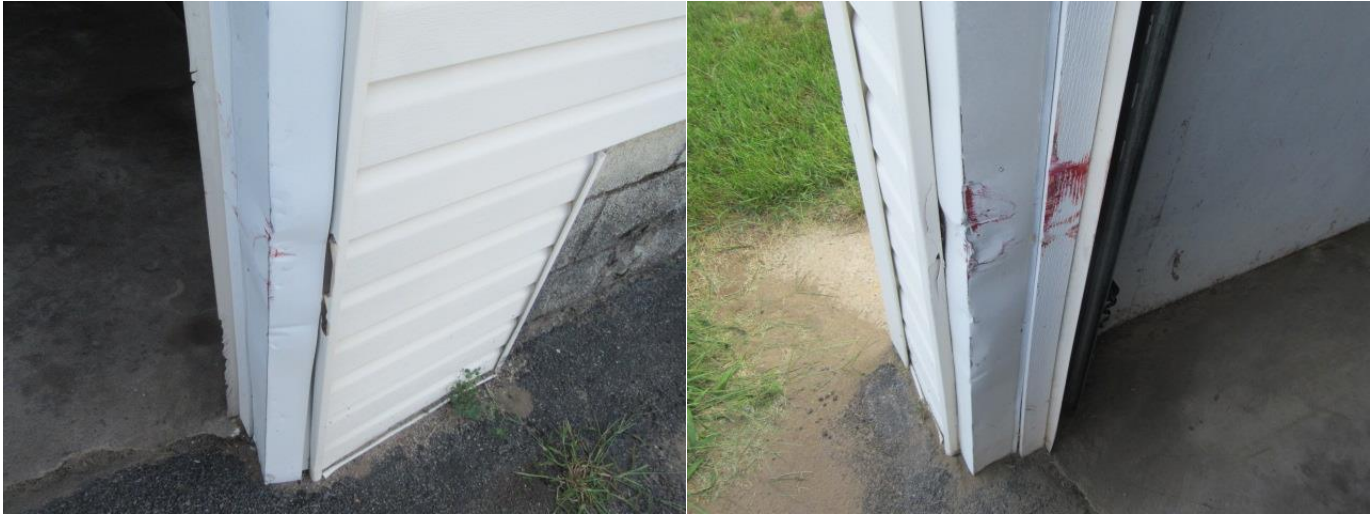
Observed damage to metal trim around garage overhead door. Trim is still functional to keep the weather out. Recommend repair if desired for cosmetic reasons.

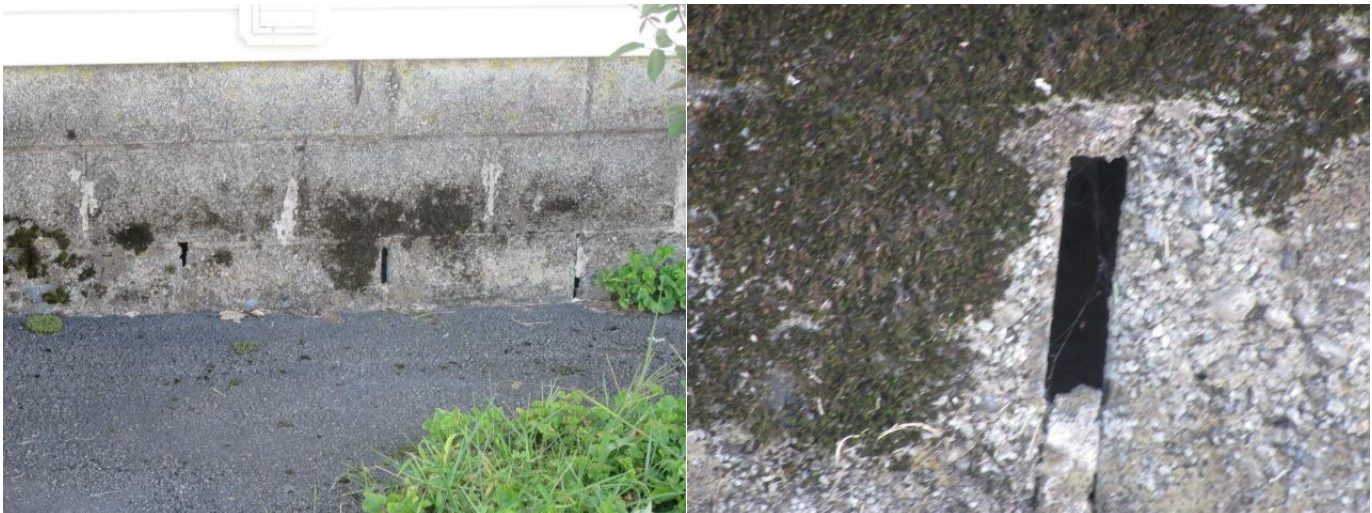
Noted missing mortar between foundation blocks on the exterior. This can allow water infiltration and lead to further damage in the future. Recommend qualified contractor repair.

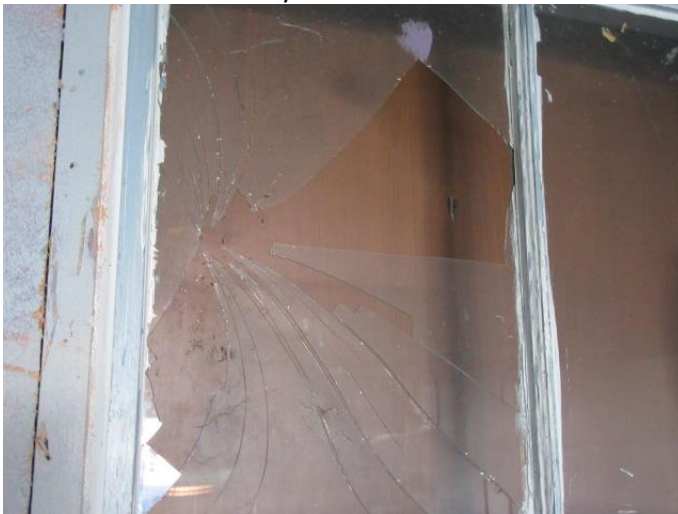
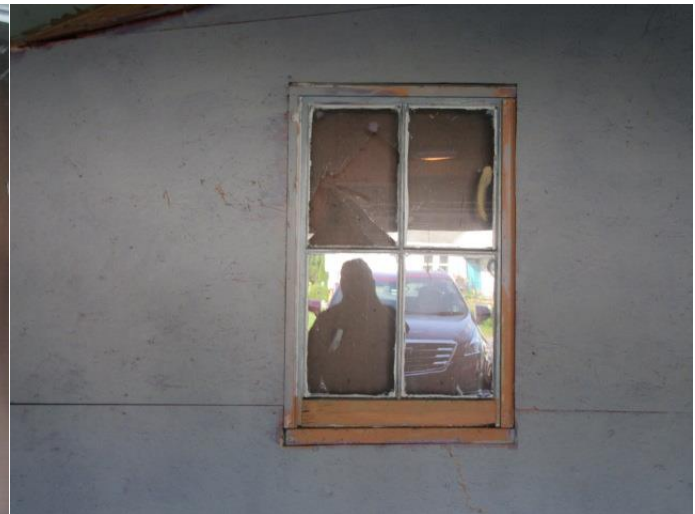
The garage vehicle door doesn't appear to "auto-reverse". Hand pressure was applied upward as the door closed and it did not auto reverse. The door should reverse when it closes onto an obstruction. Enough pressure to initiate the auto reverse may not have been applied during the test. Applying too much force when the auto reverse function does not work could cause damage to the door. Therefore, only moderate pressure was used. If the auto reverse function does not work, it could be a safety hazard, especially for small children. Recommend a qualified contractor evaluate the auto reverse function of the door opener and repair if needed.

Observed a window that was walled off on the outside. The window itself was broken and is a safety hazard. Recommend qualified person repair. Ideally the window should be repaired and made fully functional or removed and wall cavity closed.

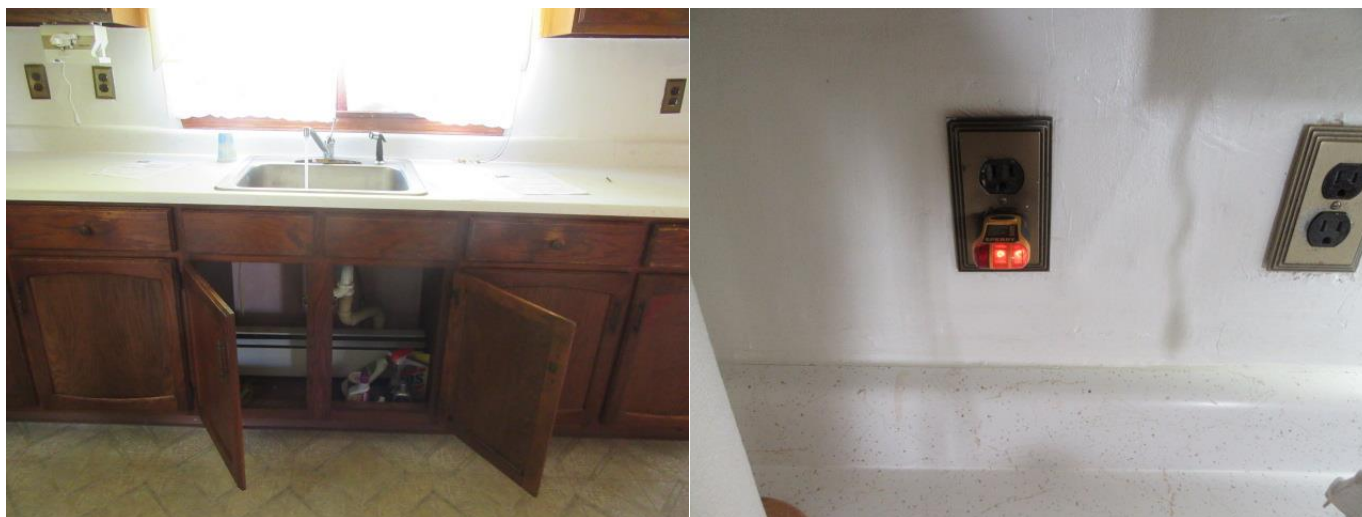
+ No ground fault circuit interrupter (GFCI) devices (outlets or circuit breakers) are visible for the kitchen. GFCI devices help prevent electric shocks in areas that may have water present. Recommend having a qualified contractor install GFCI protection for outlets over counter tops and around sinks.

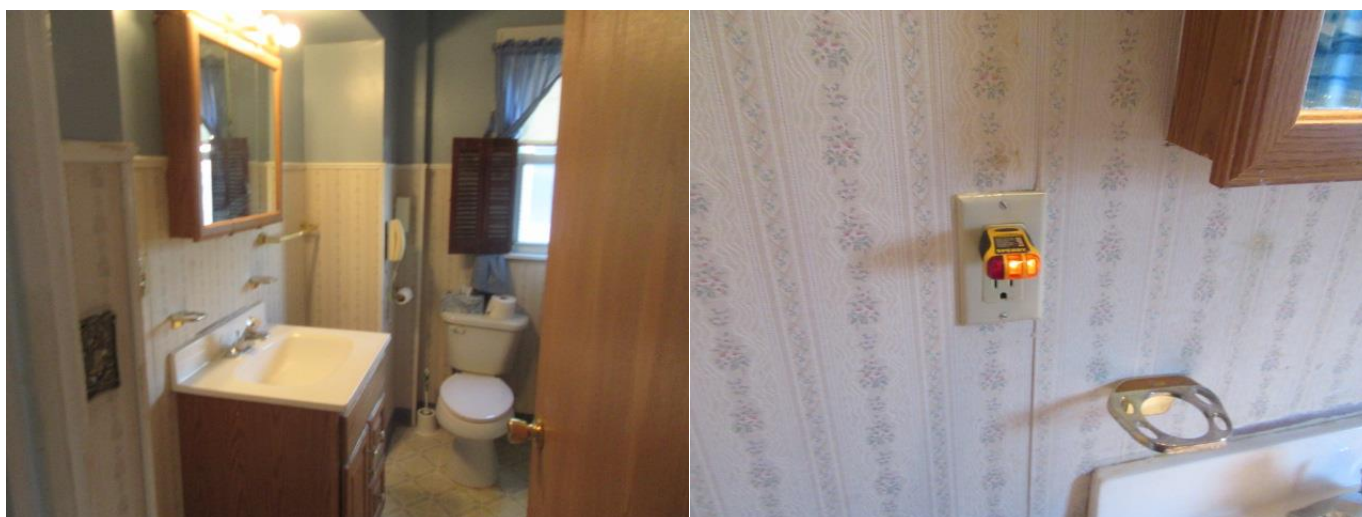
+ Tested the GFCI outlet in the bathroom and it did not trip. GFCI devices help prevent electric shocks in areas that may have water present. Recommend a qualified contractor repair.

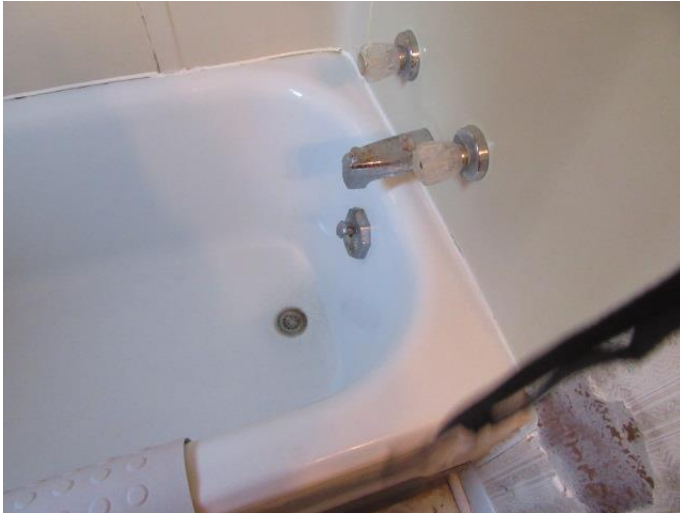
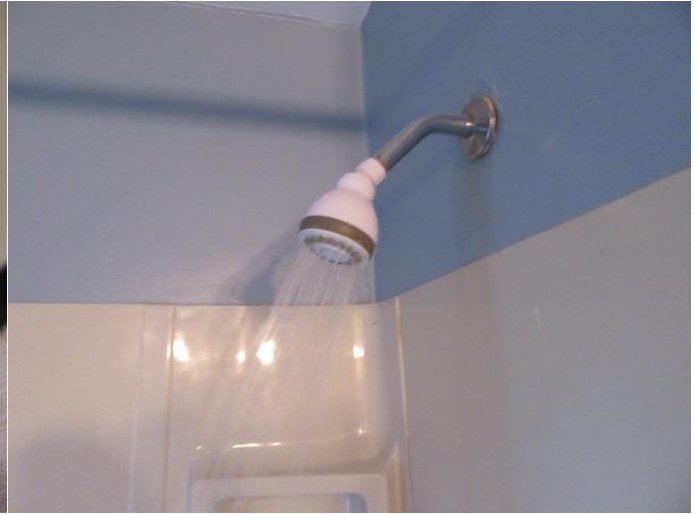
Observed leaky shower head and the tub drain stopper did not function to keep water in the tub.
Recommend qualified contractor repair.

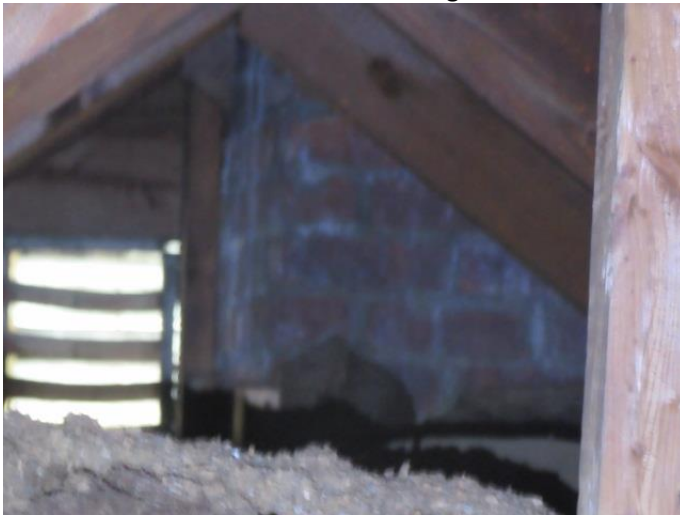
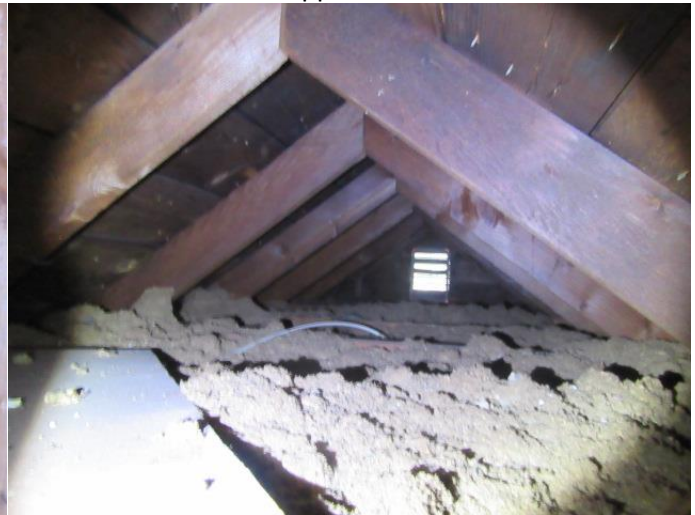
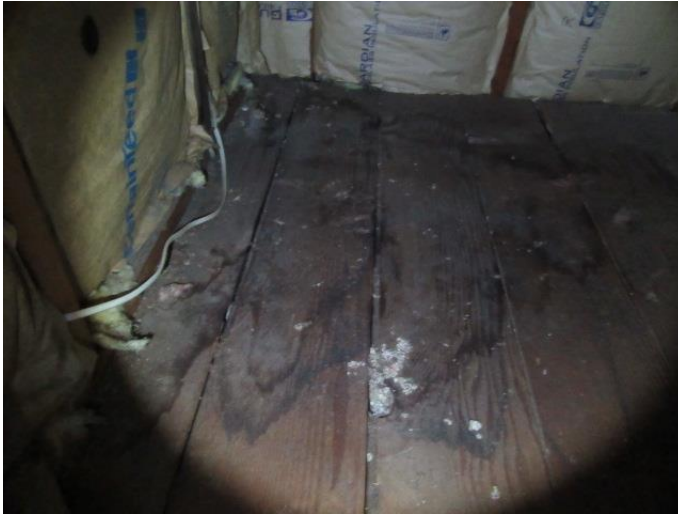
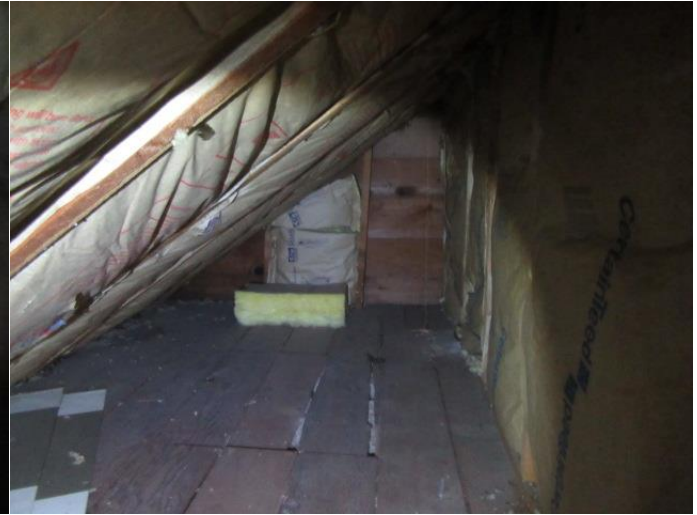
General pictures of the attic space. Observed no significant defects in the attic spaces. Some dried water stains were visible on the attic flooring in the attic section near the eaves. These appeared to be old stains.

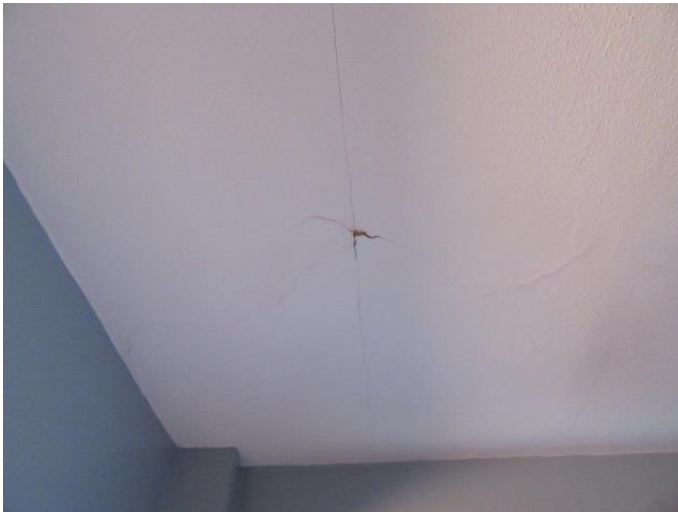
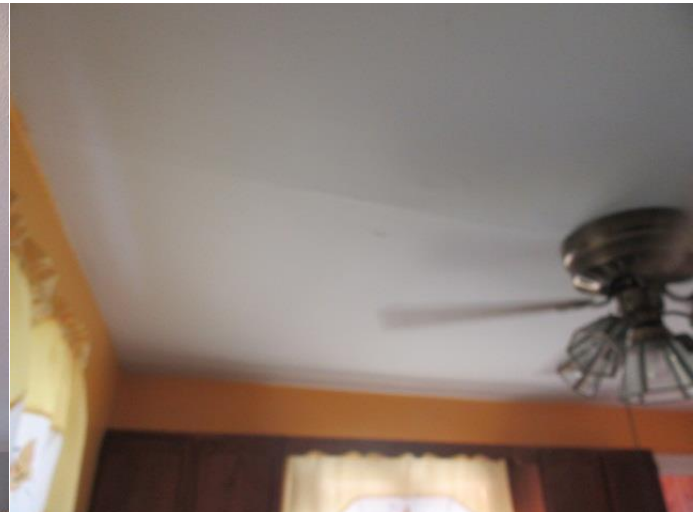
i Observed multiple cracks in ceiling. They appeared non-structural and merely cosmetic. Recommend qualified contractor repair if desired.

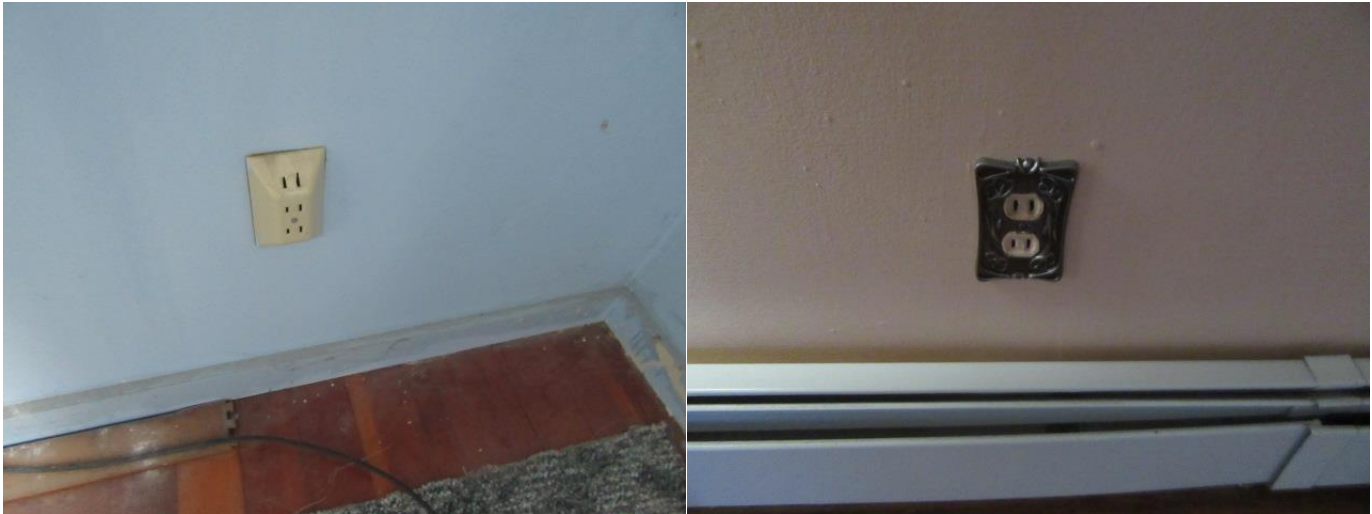
i Observed two prong outlets. This is common for older homes and is not considered a defect. Properly grounded three-prong outlets add an additional level of protection for the person and the appliance in the event the exterior casing of an appliance becomes electrified. A home is not less safe because it has two prong outlets if all appliances requiring a ground are grounded properly. Recommend home owner consider replacing two-prong

outlets with three-prong outlets if grounding is required for the appliance. Recommend consulting with a qualified electrician to determine all options.

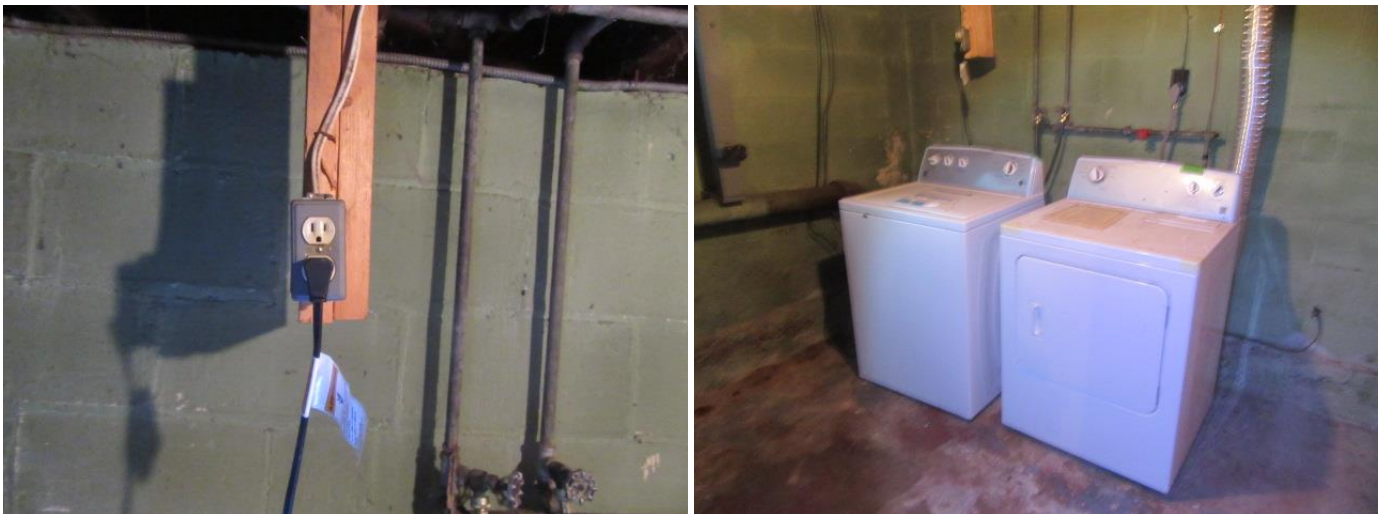
No ground fault circuit interrupter (GFCI) outlet present for the clothes washer. GFCI outlets help protect from accidental shock in areas near water. Recommend repair by qualified contractor.

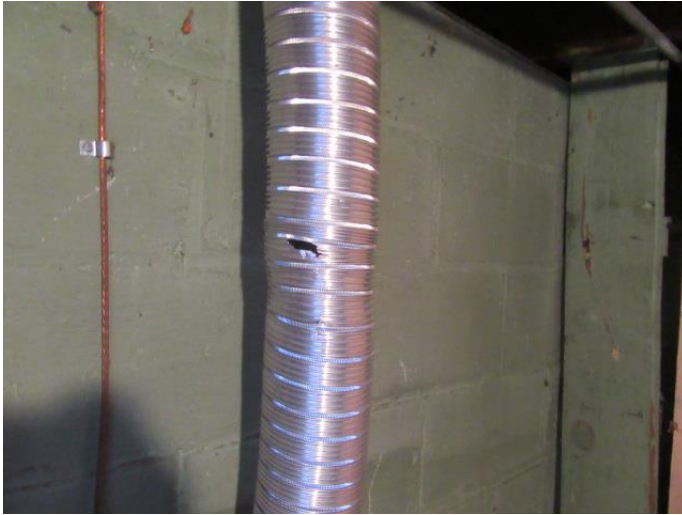
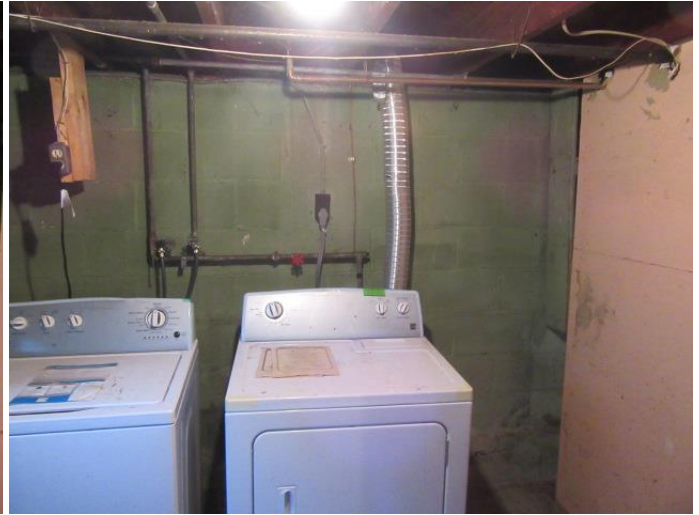
Observed a tear in the clothes dryer vent duct. This could allow lint to catch the edge and build up causing a clog or allow some moisture to escape into the basement area. Recommend qualified person repair.

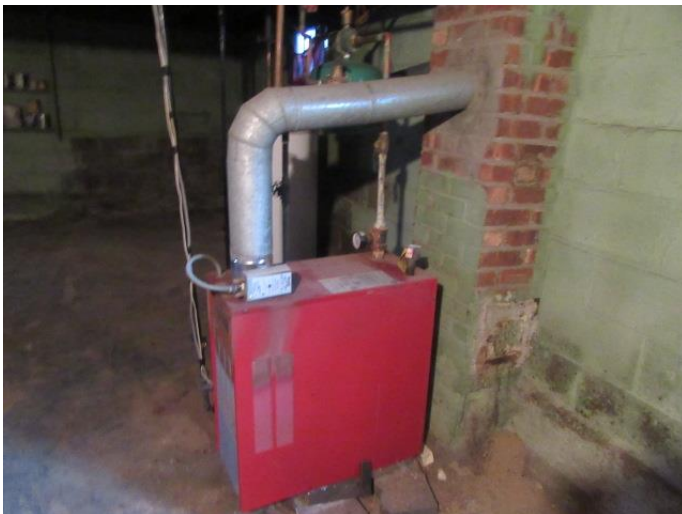
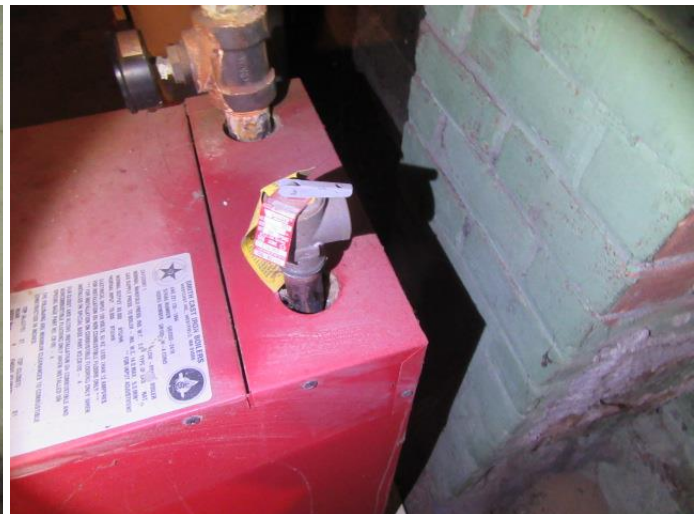
No safety extension installed on the boiler's temperature and pressure relief valve. This is an inexpensive threaded plastic pipe that attaches to the valve to direct hot water to the floor in the event the system has excess pressure built up. This is a safety device to protect people from being scalded if they are near the boiler when the pressure is released. Recommend a qualified person repair.

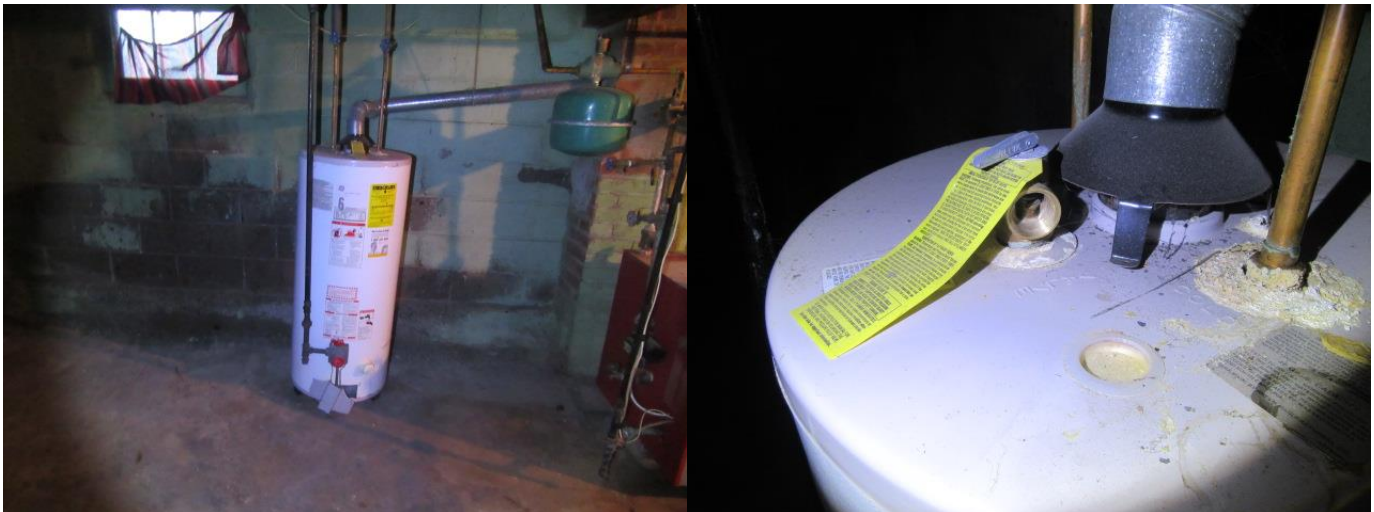
No safety extension installed on the hot water heater's temperature and pressure relief valve. This is a safety device to protect people from being scalded if they are near the heater when pressure is released. Recommend a qualified person repair.

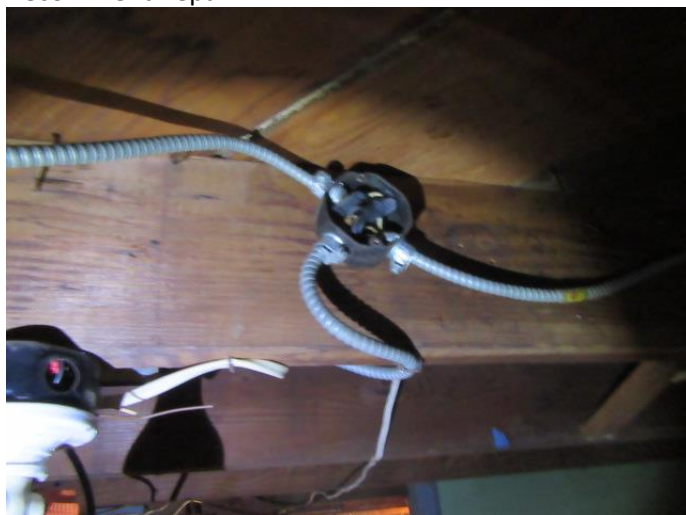
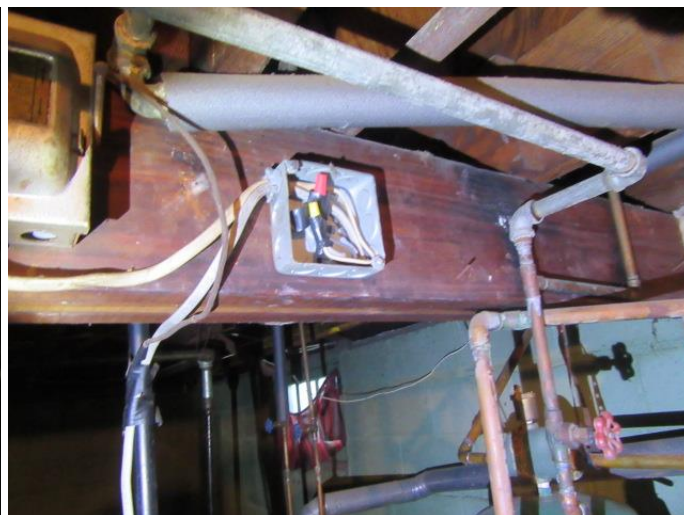
Observed multiple junction boxes in basement with no covers. This is a potential shock hazard.

Recommend repair.

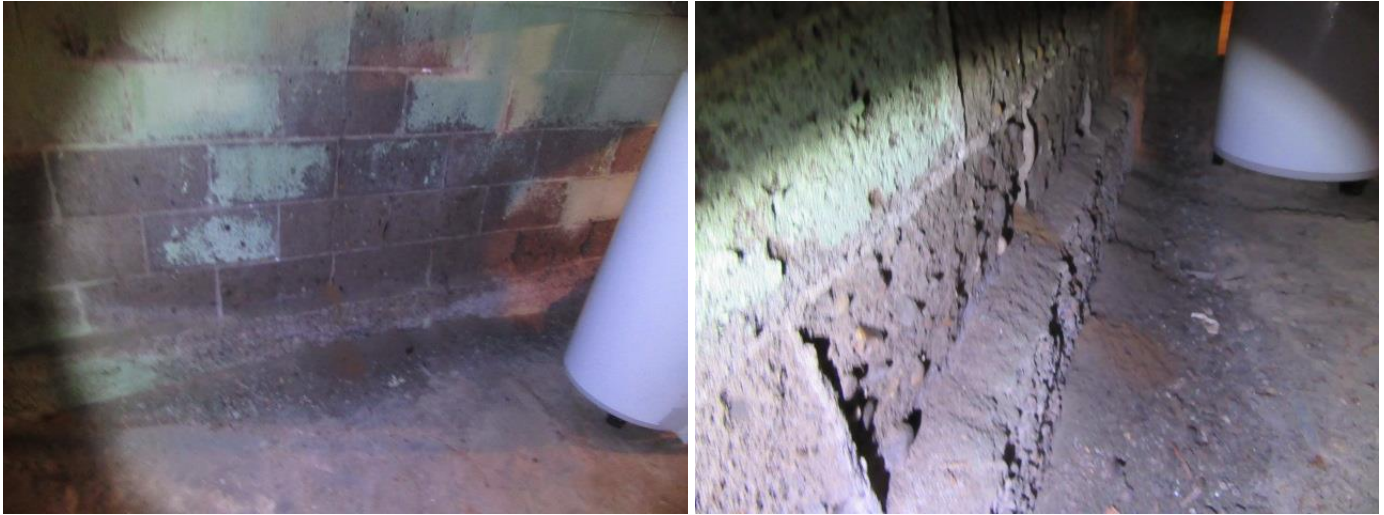
Observed spalling of some portions of foundation concrete block. Spalling is a condition where the surface of a masonry structure such as concrete block or brick will slowly deteriorate. The process can continue with increased deterioration. This can occur due to the presence and movement of moisture. Hydrostatic pressure can push moisture and salts through the block causing the damage at the surface. Recommend qualified contractor repair effected blocks. To prevent future deterioration, recommend considering ways to keep water away from the foundation walls. Consider regrading within 6 ft of the foundation to slope water away and consider installing gutters on the roof with extensions to direct water away from the foundation. Also recommend avoiding the use of paint on the basement walls, which tends to lock in the moisture inside masonry.
