## Client

Jane Doe  
1945 Inspection Way  
Home Town, 12345  
HIN™: 123451304  
Email:  
Inspection Date: 10-14-2017

## Inspector

TriCheck Home Inspections LLC  
Bob Patton  
24 Oxford Circle  
Troy, New York 12180  
Phone: (518) 961-2522  
E-Mail: [trichheckinspections@gmail.com](mailto:trichheckinspections@gmail.com)

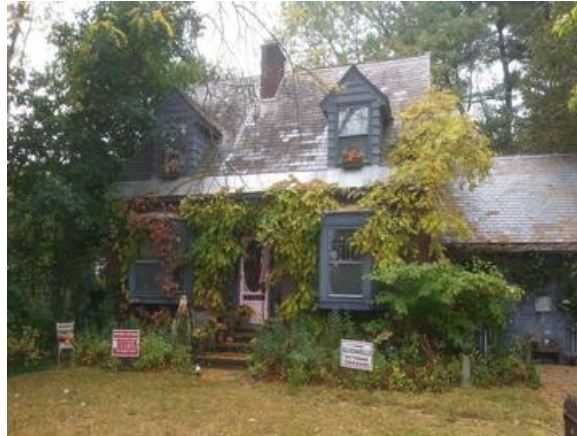
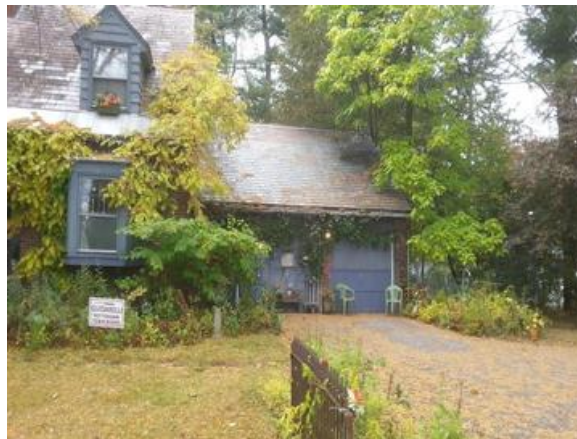
10/15/2017 The house number could not easily be seen from the street. This is a safety hazard in the event emergency personnel are called to the house. Recommend installation of house numbers that can be seen easily from the street in day or night.

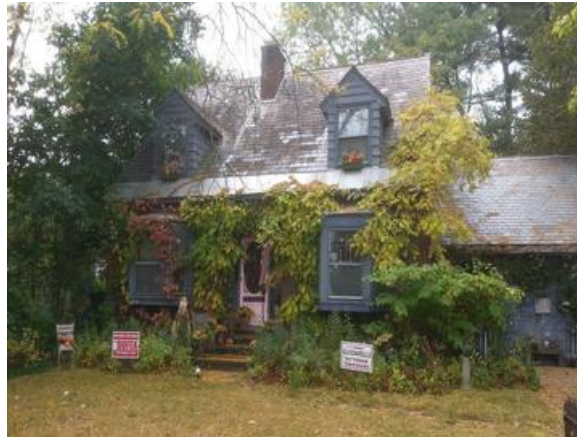
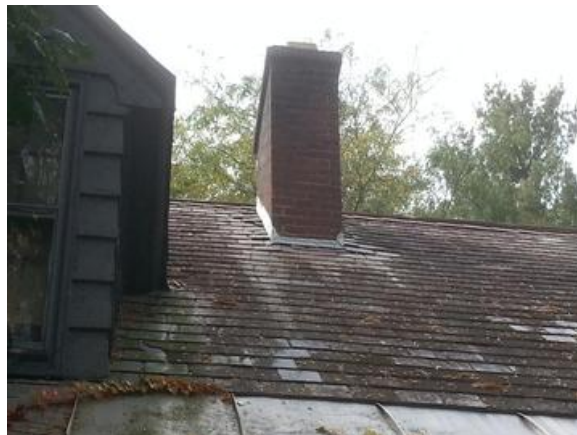
Chimney missing rain cap/spark arrester. This can lead to water infiltration and deterioration of chimney masonry. A missing spark arrester also increases fire hazards by allowing embers to escape and land onto something flammable. Recommend contractor repair.

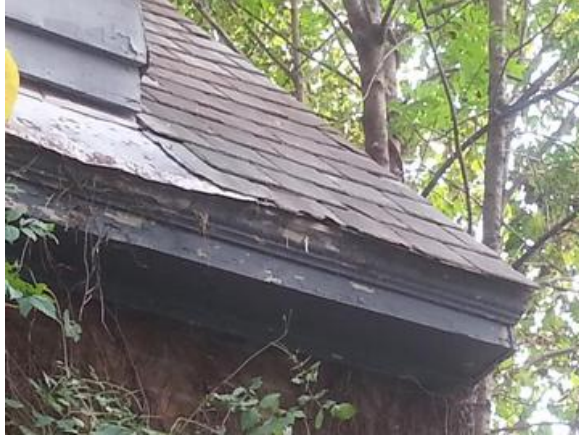
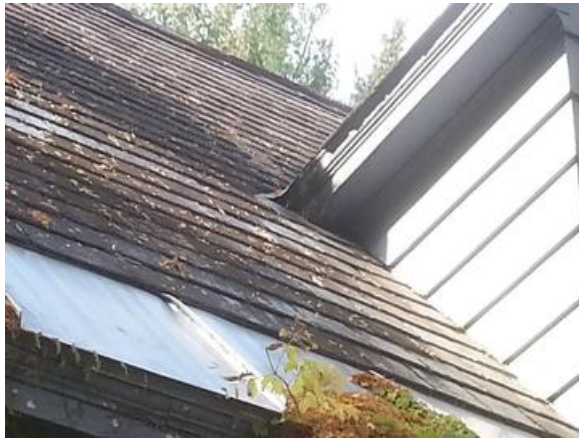
10/15/2017 Observed chipped slate on eaves. This allows rain water to hit and infiltrate the wood trim below. Recommend qualified contractor repair.

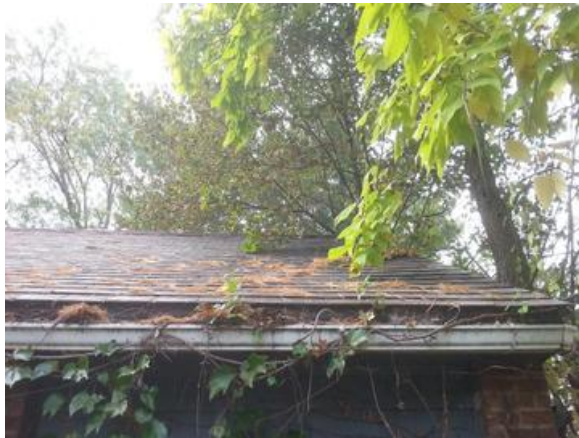
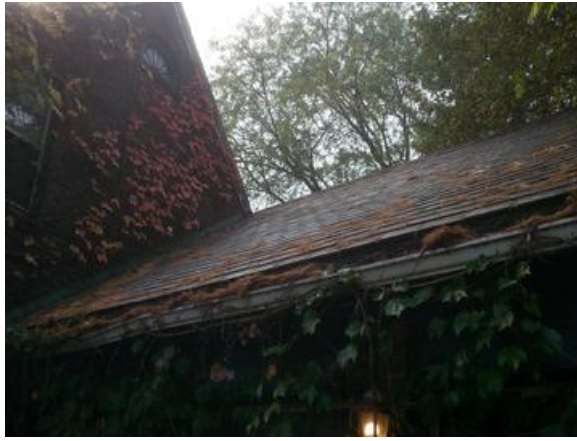
10/15/2017 Gutter located on the garage was filled with vegetation and not functional. One end was tipped toward the garage side entryway, and the downspout was rusted away. This condition does not keep water away from the foundation or the side entry area. Recommend qualified contractor repair.

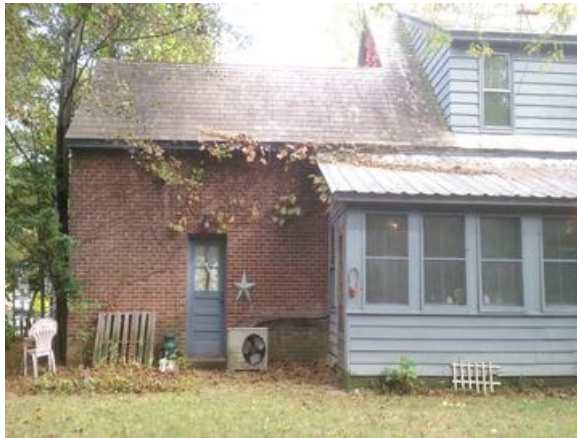
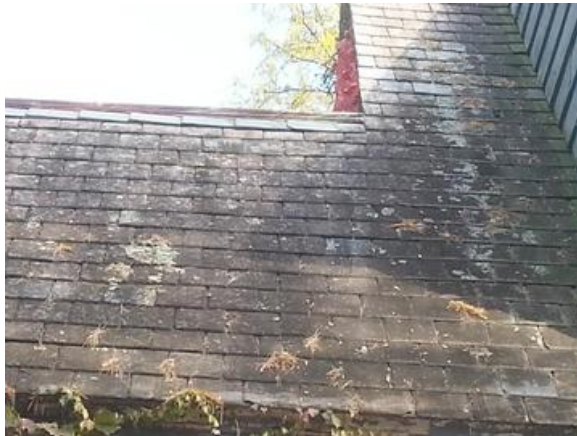
Observed presence of lichen growth on roof surfaces. While this is not expected to have much impact on the roof life, it does alter the appearance. Recommend contacting qualified roof cleaner if desired to be removed.

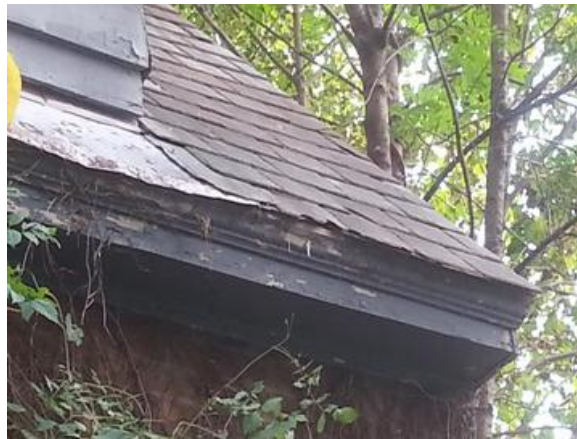
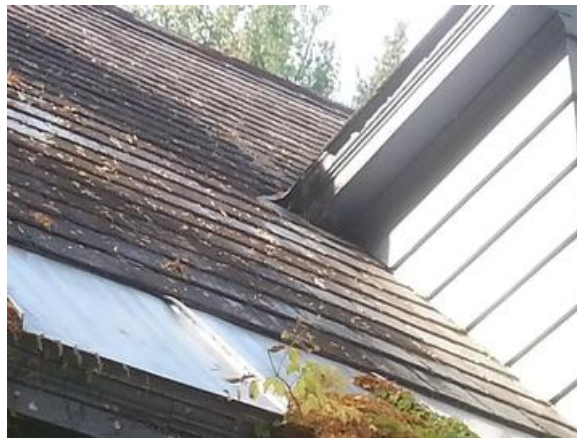
Wood rot observed on trim at locations where slate had chipped and exposed the wood to rain water. Recommend repair by qualified contractor after the broken slate pieces are repaired.

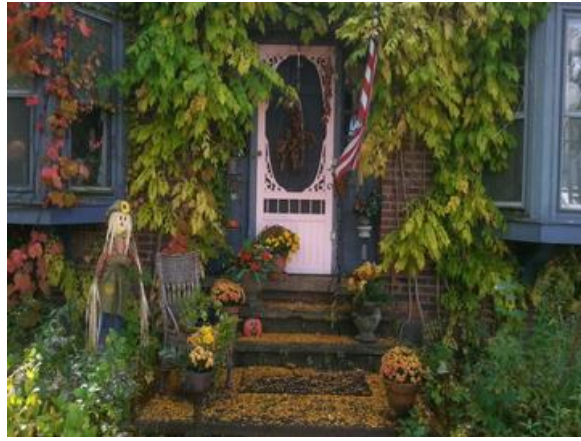
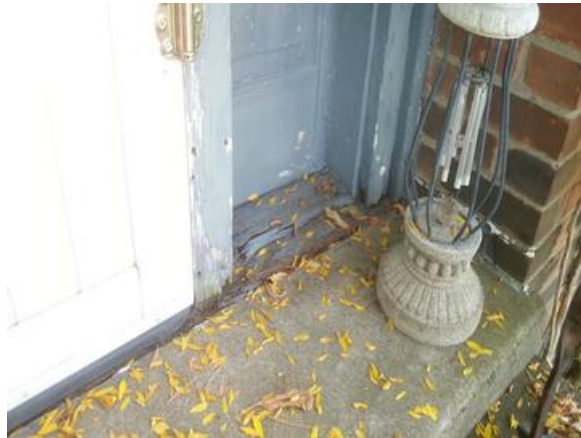
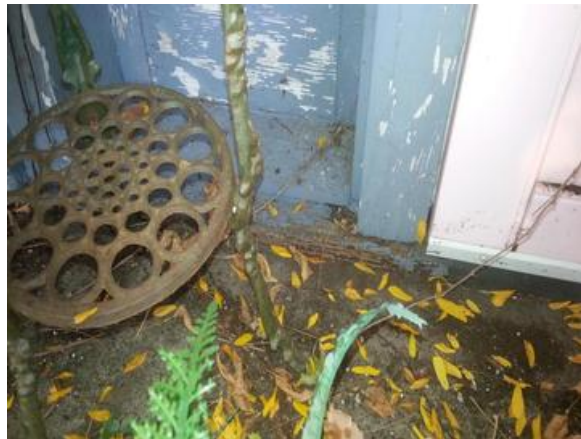
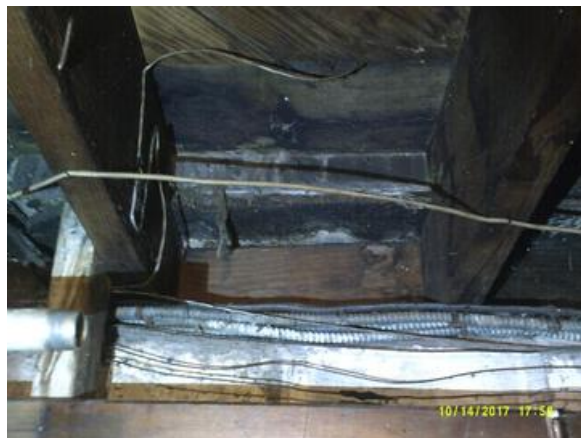
Wood rot observed at bottom of front door. Further investigation revealed wet and rotted wood was visible from the basement at the entry location. Recommend qualified contractor repair to prevent further deterioration.

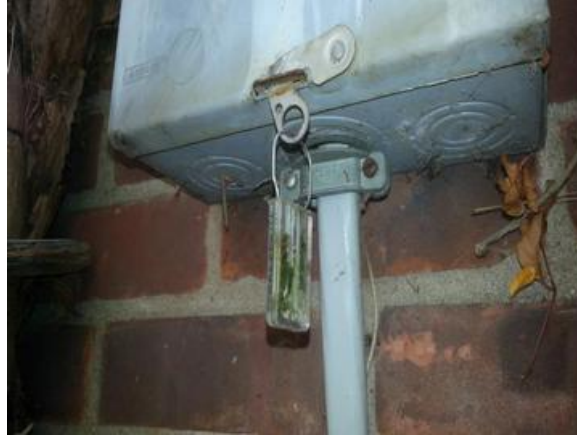
Meter caulking is insufficient and needs to be recaulked. A gap exists between the wire connector and box at the bottom of the meter box, and it is not sealed. This may allow moisture penetration to occur. Recommend a qualified contractor repair as necessary.

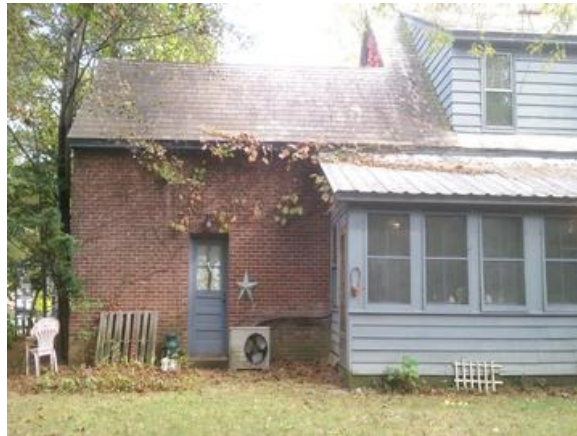
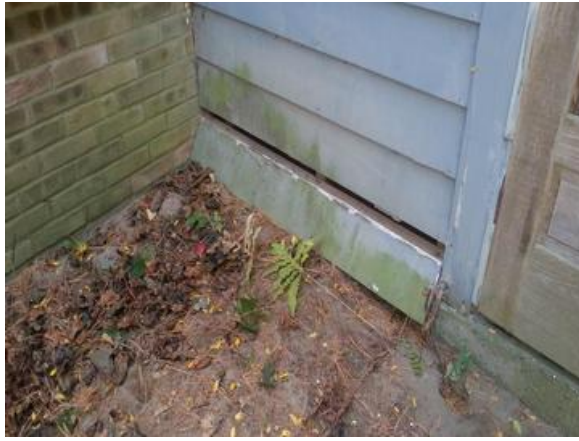
Broken wood siding on covered patio. This can lead to water or pest infiltration. Recommend qualified contractor repair.

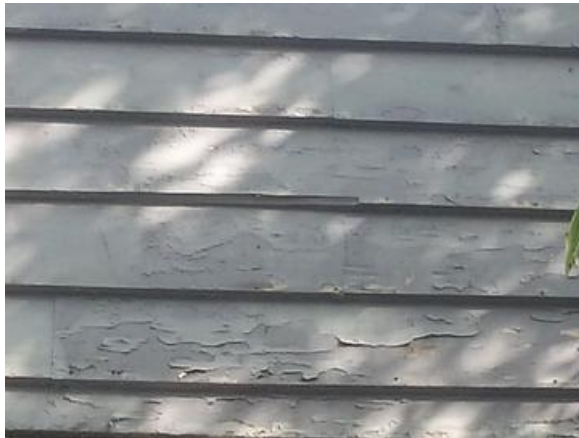
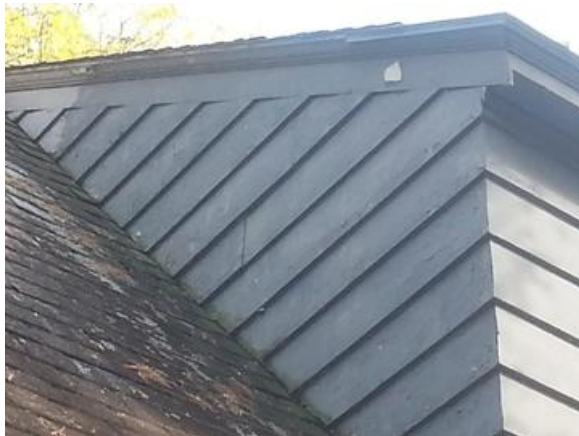
Chipped and peeling paint on wood siding at multiple places. This can lead to water infiltration. Recommend qualified contractor repair.

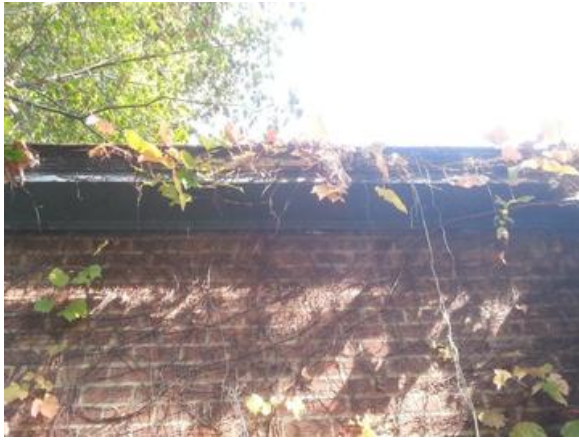
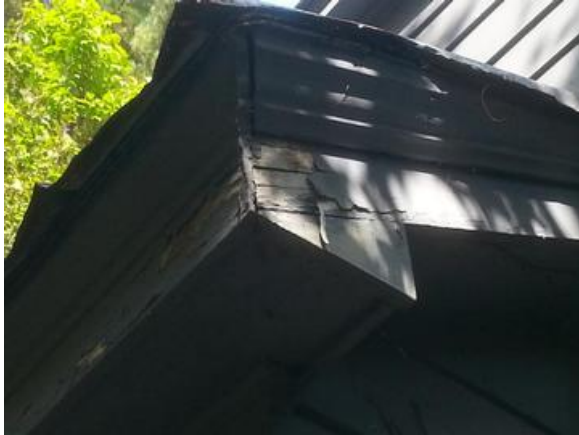
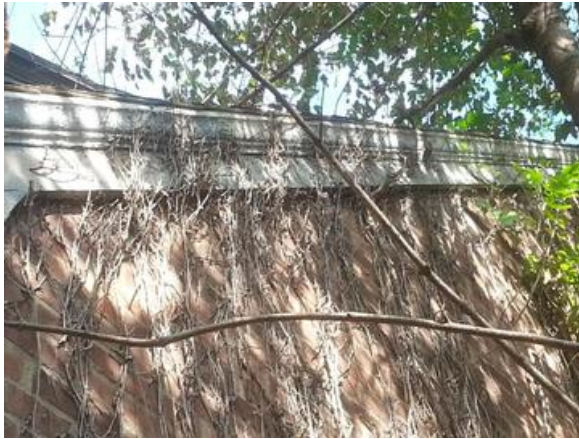
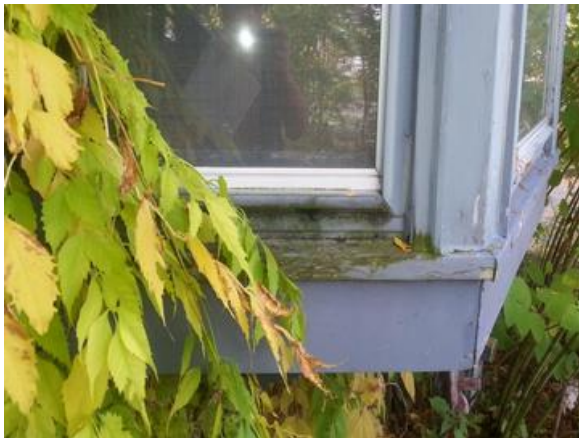
Observed peeling paint on wood trim all around the home. This allows water infiltration and can lead to wood rot. Recommend repainting trim by qualified contractor.

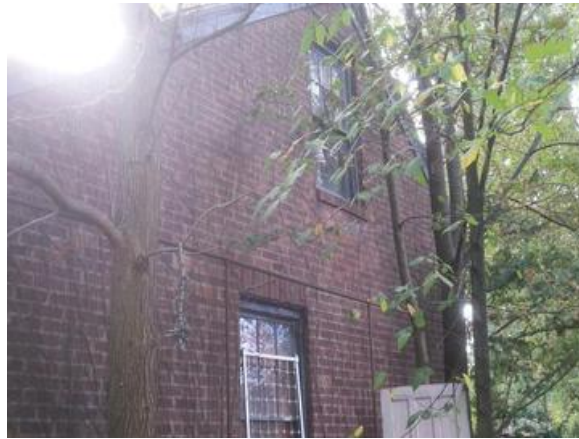
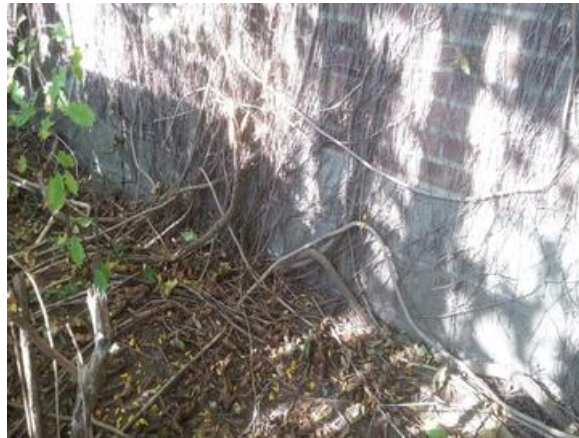
Was unable to perform a complete visual inspection of all exterior wall and foundation surfaces due to dense vine coverage on all sides of the home.

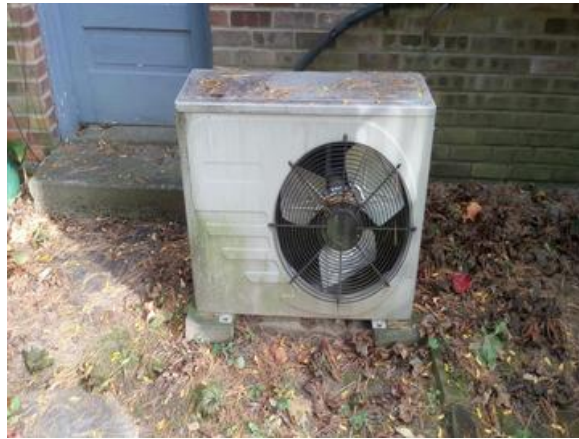
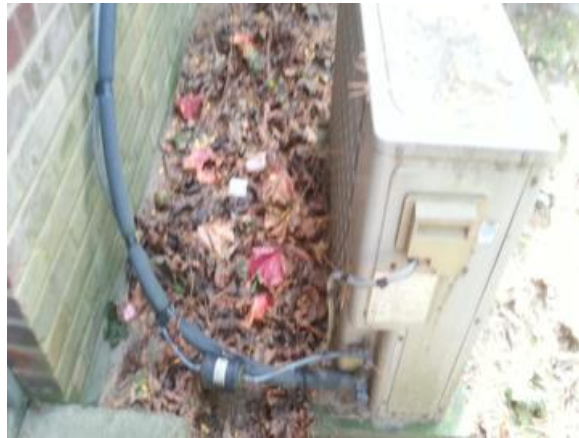
Was not able to locate a disconnect switch for the A/C unit. All A/C units should have a disconnect switch within site of the condensing unit. Recommend repair by qualified contractor.

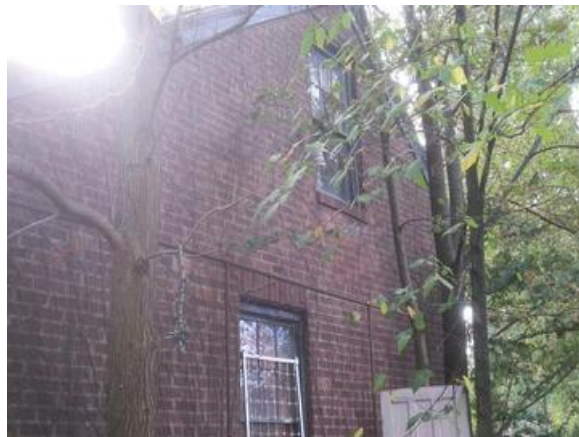
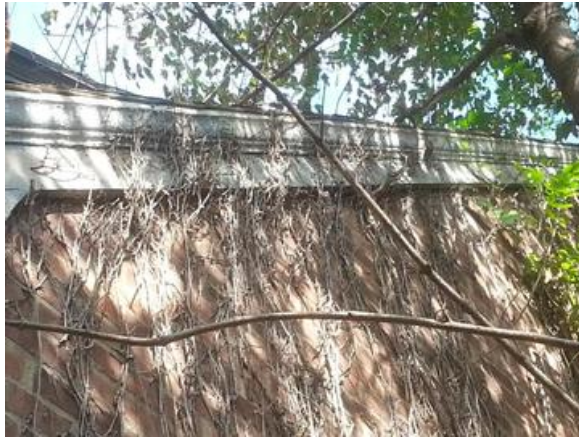
All sides of the home were covered in vines and vegetation. Vegetation growing on the home can damage masonry and other exterior surfaces. The vegetation can also make it difficult or impossible to perform periodic maintenance, such as painting of wood trim. Recommend qualified contractor remove vegetation properly so as to not damage the exterior surfaces of the home.

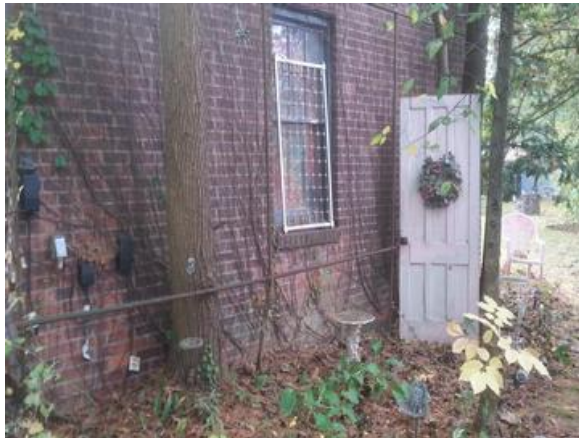
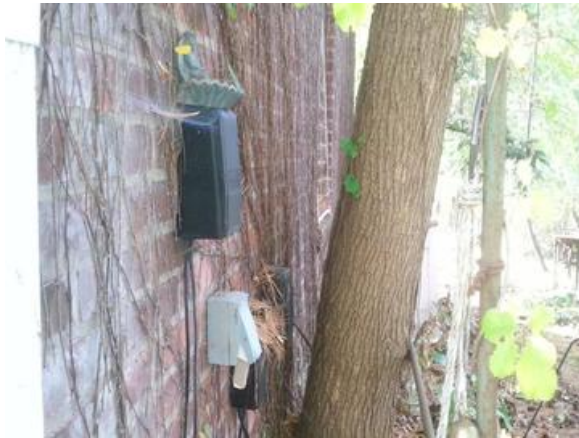
Trees were too close the house. Some tree trunks were in direct contact with the garage, which can lead to compromise of the foundation and wall structure. Recommend removal by qualified tree service.

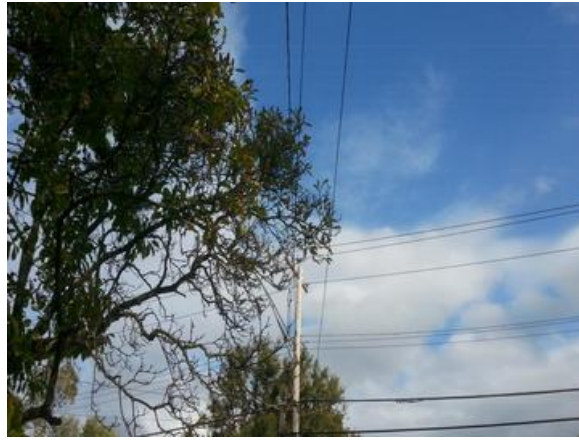
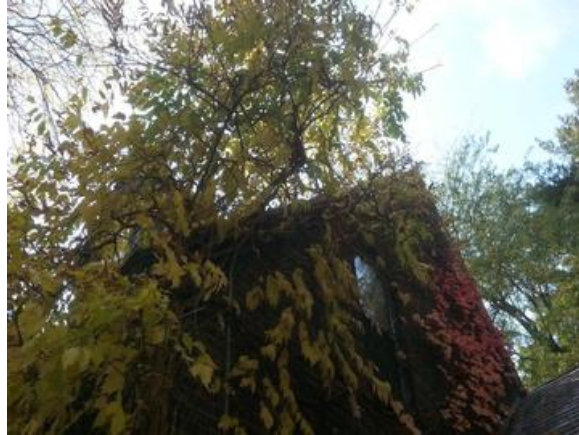
Ivy was growing on and weighing down cable and phone lines attached to the home. This could lead to the lines breaking or pulling away from the house. A tree near the road was also growing over these lines, and will eventually become a hazard for to the lines. Recommend repair by qualified contractor.

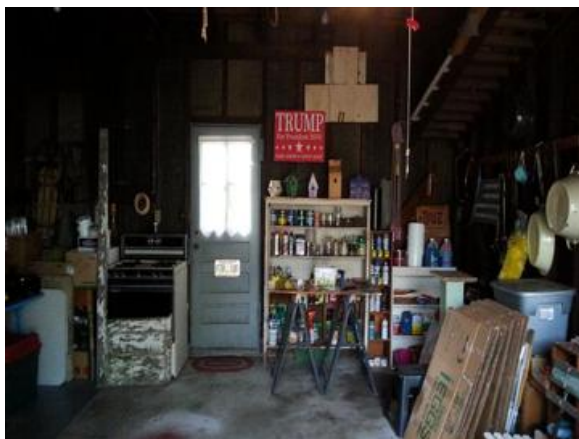
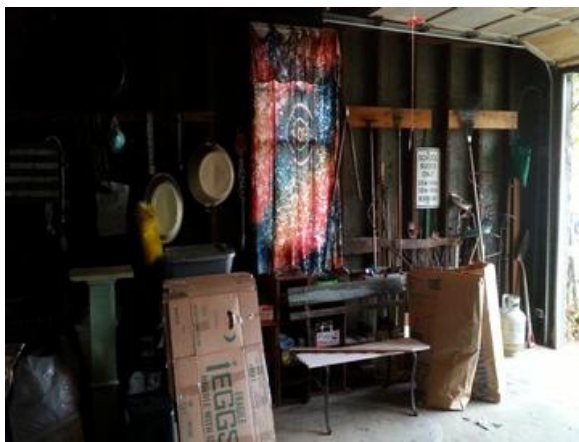
10/15/2017 No drywall on interior garage walls or ceilings. Drywall can help contain a fire to the garage, allowing more time to escape and to save the home. Recommend repair by qualified contractor.

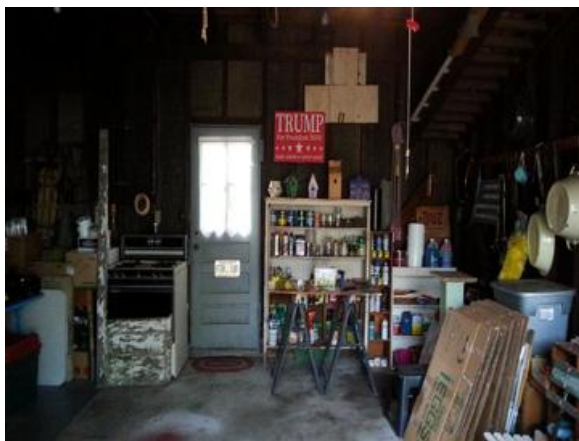
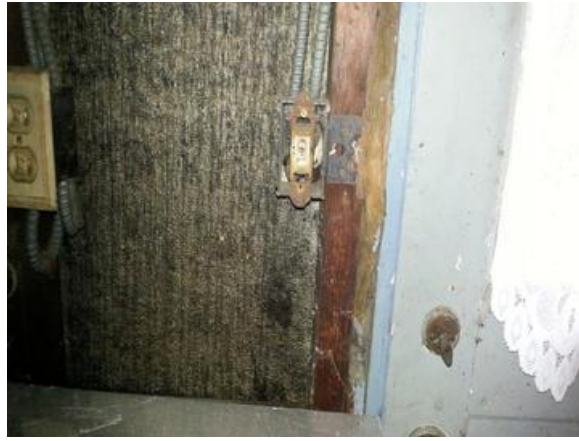
10/15/2017 Missing switch cover plate. This can increase risk of electrical shock. Recommend repair by qualified contractor.

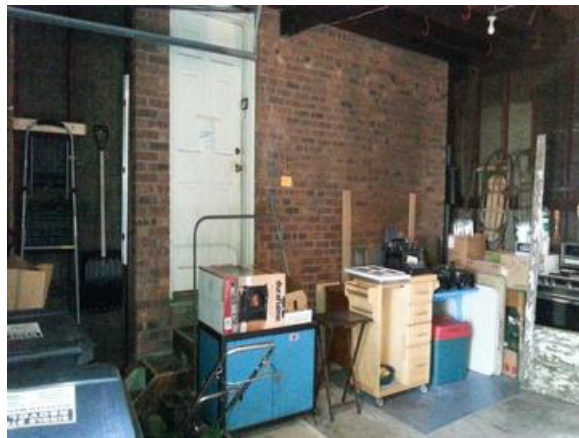
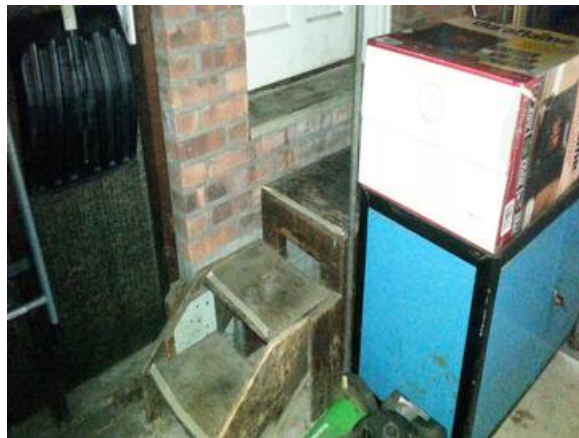
Steps to interior were narrow. This may impede egress in an emergency. Recommend repair by qualified contractor.

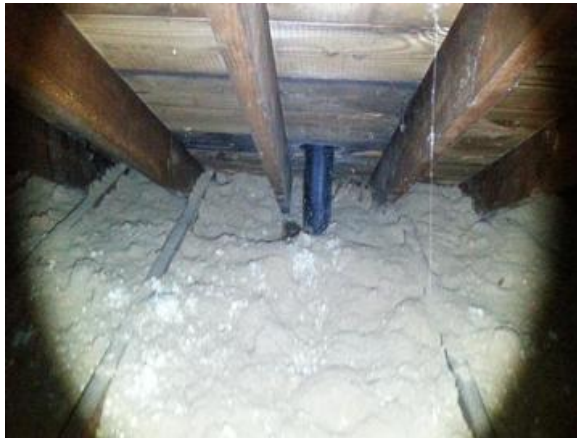
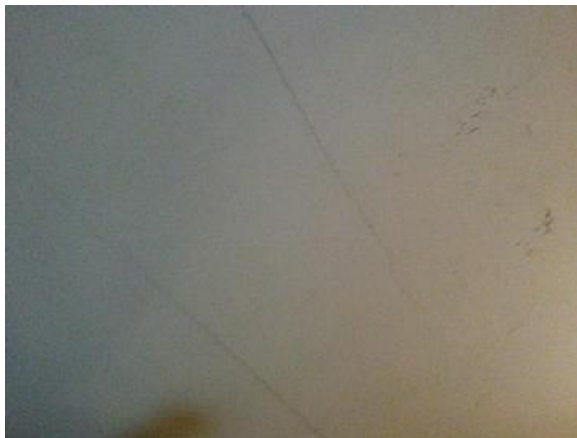
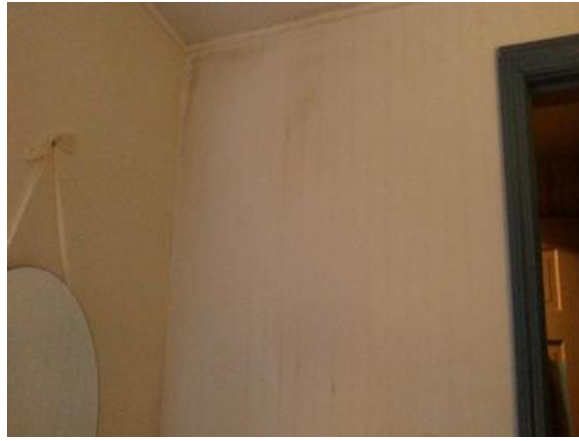
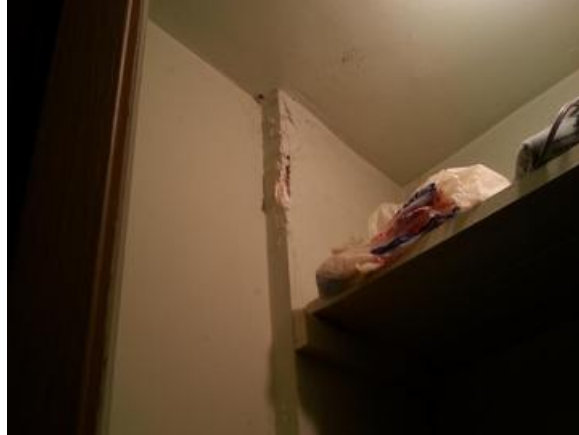
Observed what appeared to be an active leak near the plumbing vent pipe. A dark spot was noted on the insulation next to the pipe. Recommend qualified contractor repair leak in roof near vent pipe.

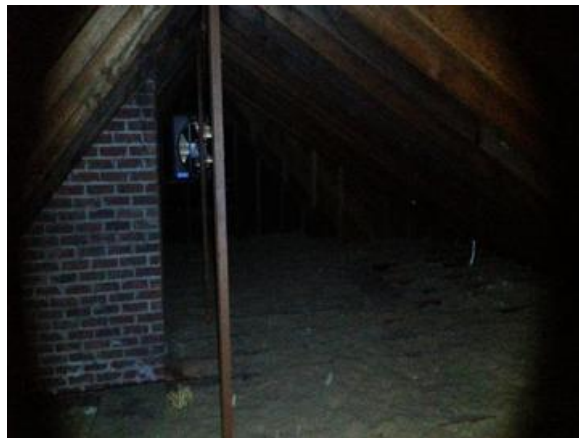
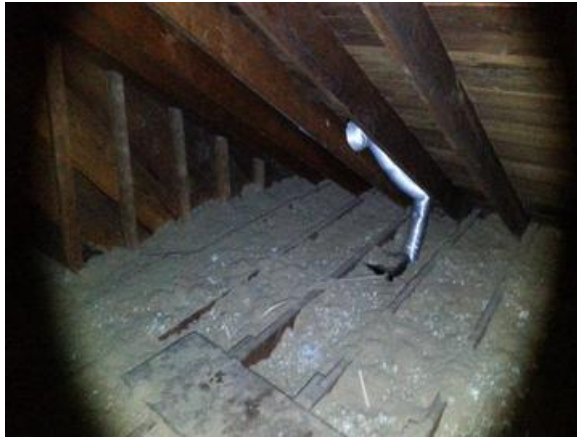
Exhaust from bathroom fan terminates into the attic. This allows the fan to put moisture into the attic space and could promote mold growth. Recommend qualified contractor repair.

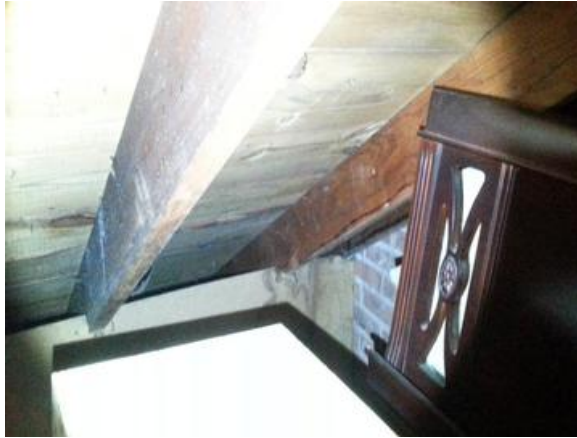
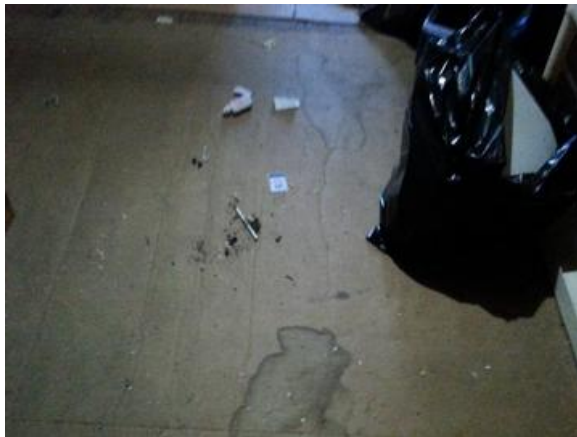
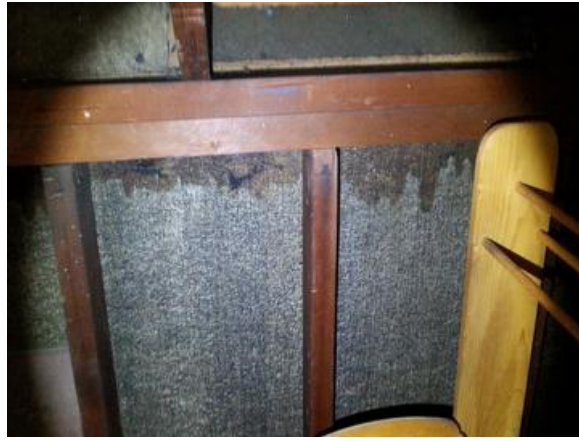
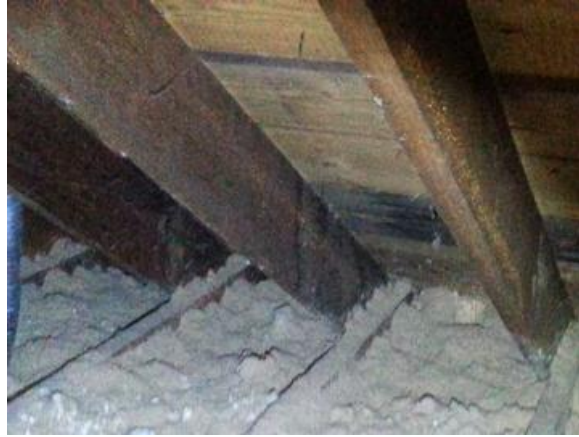
Stains were visible on the roof structure in one or more areas. These areas were dry at the time of the inspection. The stains may be caused by a past leak. The client should monitor ceilings below these areas in the future, especially after heavy rains, to determine if active leaks exist. If leaks are found, a qualified contractor should evaluate and repair as necessary.

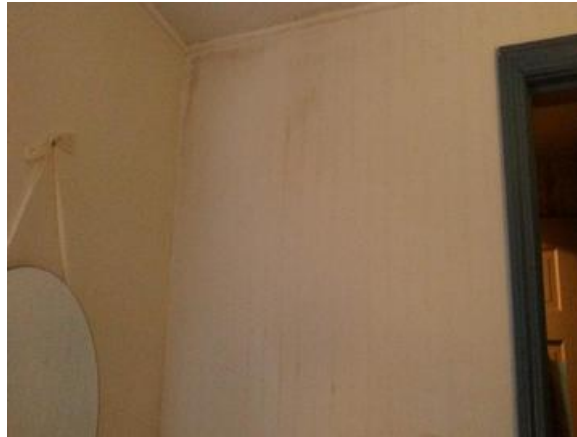
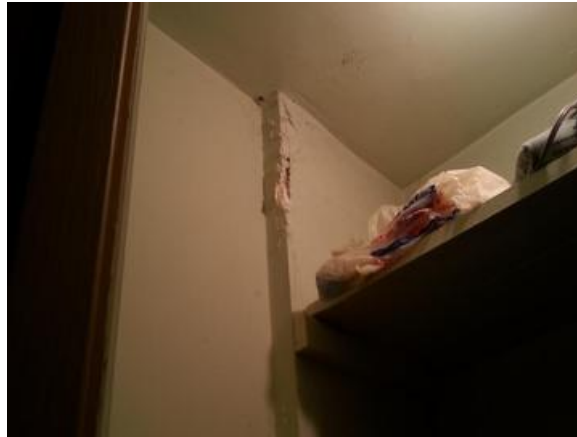
Evidence of water damage found within the wall/ceiling areas between the second floor bath and hall closet. The bathroom wall paneling was buckled and stained. Sheetrock damage and staining found in the closet. The location of the water damage is directly below the site of the leak found in the Attic section of this report. Recommend qualified contractor repair the damage to the interior walls when the roof leak is repaired.

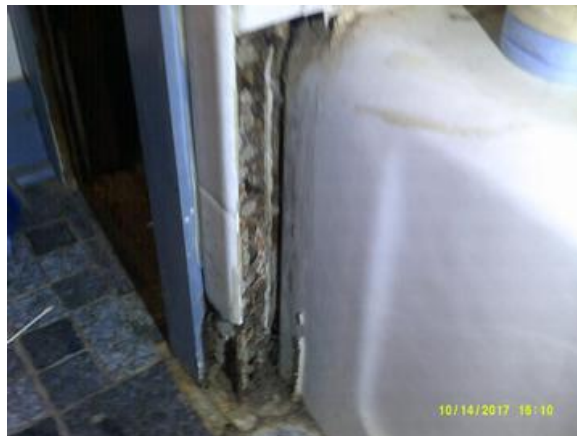
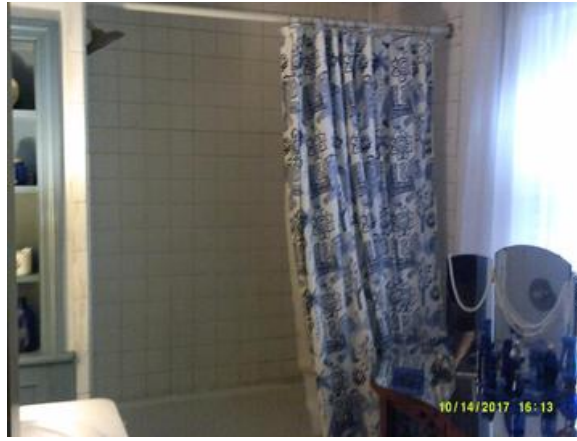
Damage to bottom corner of wall appeared to be from water infiltration from the shower/tub. Recommend qualified contractor repair.

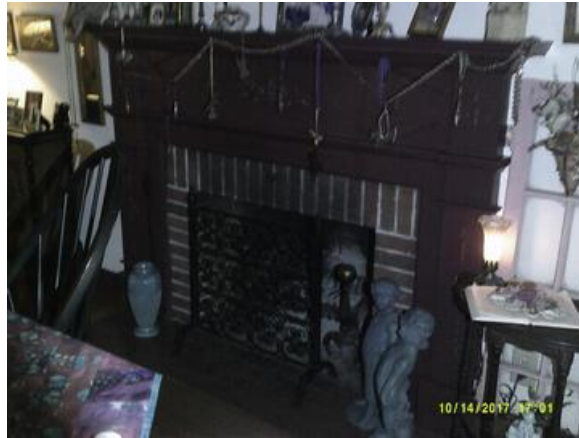
Damper for basement level fireplace did not open. Attempted to turn the damper handle, but damper was stuck closed. Recommend repair by qualified contractor. First floor damper worked correctly.

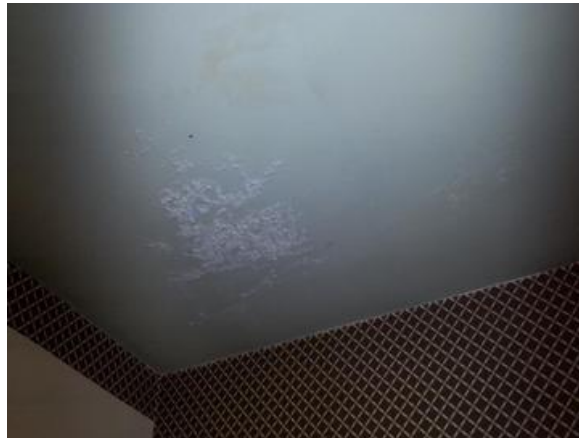
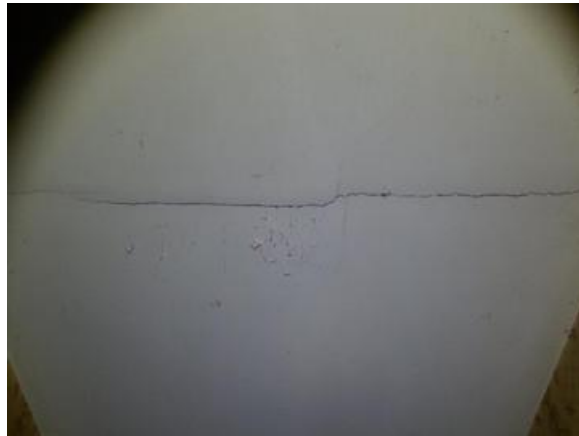
Second floor ceiling had peeling paint and cracks at multiple locations. This may have been caused by roof leaks at some point. Observed no evidence that these leaks were active. Recommend monitoring ceilings during next heavy rain. If any leaks present, consult a qualified roofer to repair.

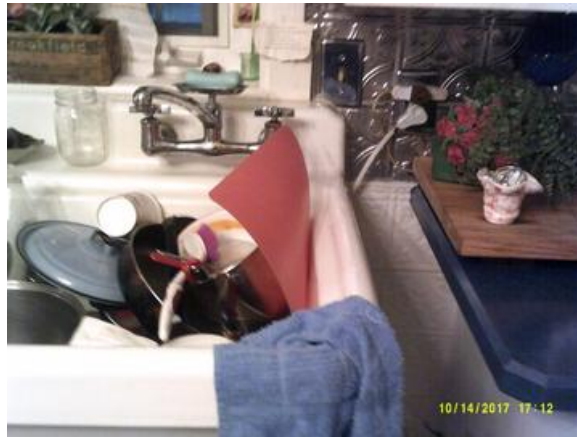
No ground fault circuit interrupter (GFCI) devices (outlets or circuit breakers) are visible for the kitchen. GFCI devices help prevent electric shocks in areas that may have water present. Recommend having a qualified, licensed electrician install GFCI protection for outlets, over counter tops and around sinks.

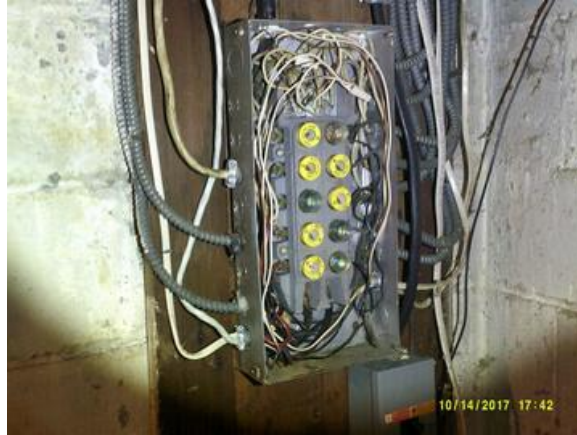
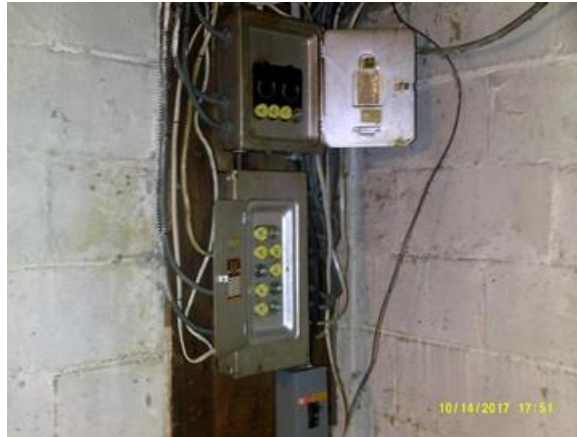
Observed multiple double-taps and triple taps in the fuse box. This is where multiple wires are connected to terminals only designed to connect one wire. This can cause micro-arcing between the circuits and failure of the fuses. Recommend repair by a qualified electrician.

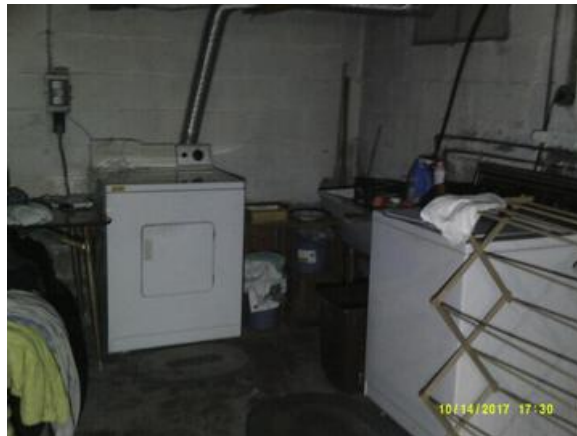
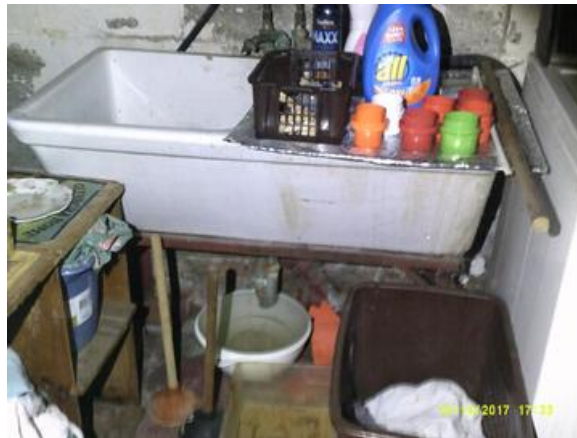
Utility sink drain leaked from around trap. Buckets under sink appeared to be used to collect leaking water. Recommend repair by qualified contractor.

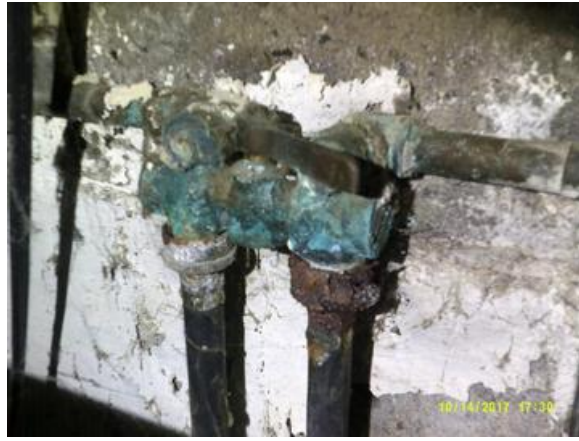
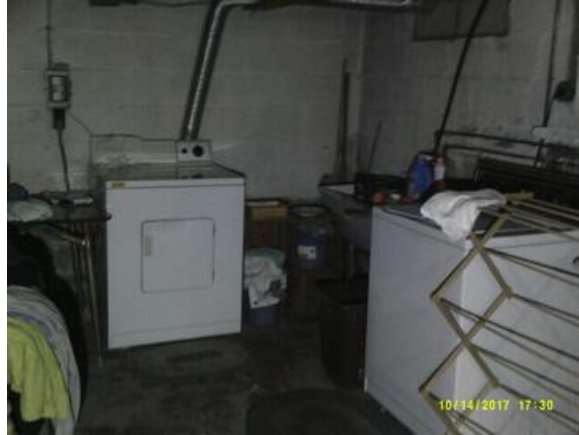
Hot and cold water supply hoses were severely corroded and are expected to be leaky. Did not operate washer for fear of complete failure. Recommend replacing hoses.

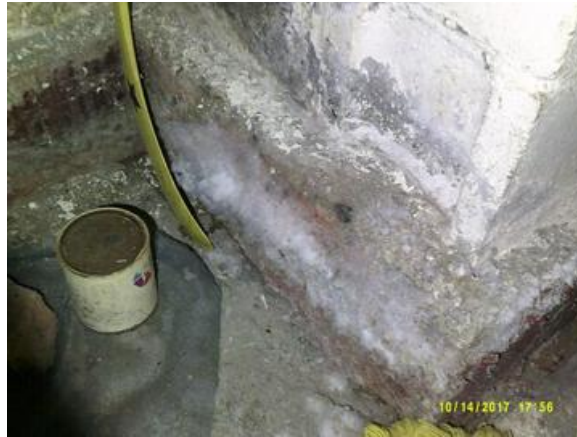
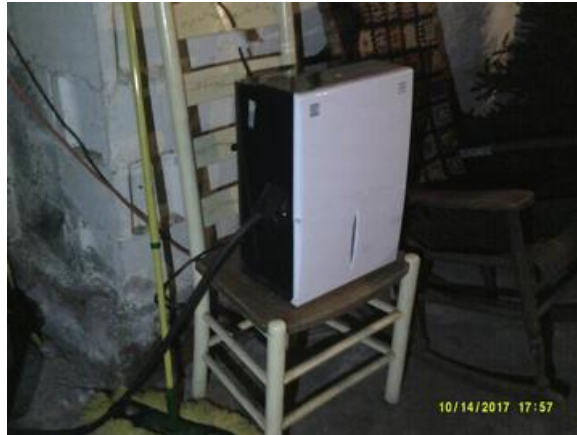
Extensive signs of moisture in basement, including presence of efflorescence, staining, sump pit full of water, and a running dehumidifier. Properly installed and maintained gutters are often effective at keeping water away from the foundation. Recommend a qualified contractor install gutters on main house and repair garage gutter as noted in the Roof and Ventilation section of this report.

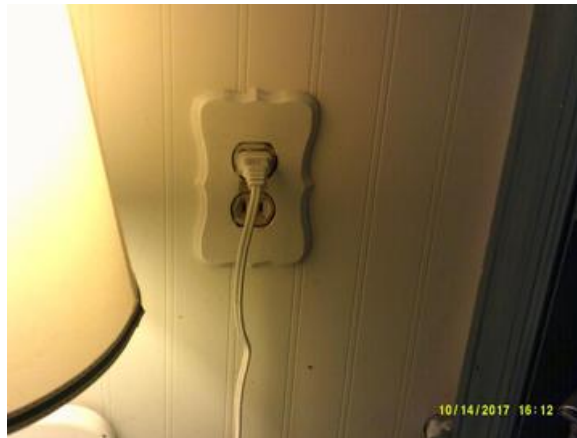
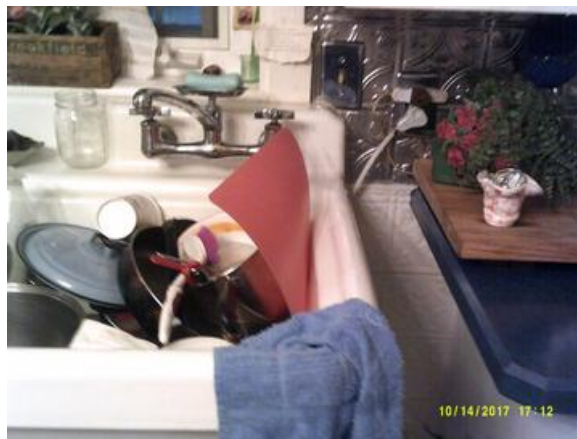
No ground fault circuit interrupter (GFCI) outlets installed in the home. GFCI outlets help prevent electric shocks in areas that may have water present. Recommend having a qualified electrician install one or more GFCI outlets over counter tops and around sinks. No GFCI outlets noted in the Kitchen, Main Bath, or Laundry area.
