Jane Doe
 1509 Inspection Way
 Home Town, 12345
 HIN™: 123459602
 Email:
 Inspection Date: 11-11-2017

TriCheck Home Inspections LLC
 Bob Patton
 24 Oxford Circle
 Troy, New York 12180
 Phone: (518) 961-2522
 E-Mail: trichheckinspections@gmail.com

Thank you for choosing TriCheck Home Inspections LLC. This report is designed to clearly and concisely inform you of the defects observed at the time of the inspection as they relate to the safety, operation, and condition of the home's components and systems.

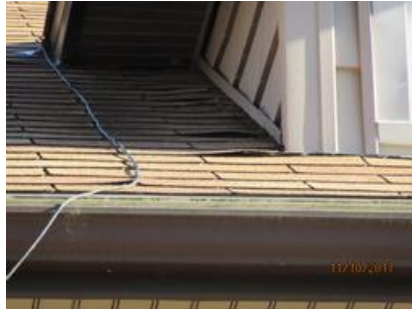
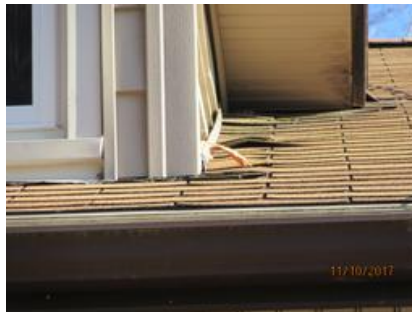
Observed lifted shingles around dormer. This can allow water and ice to penetrate to the roof decking. At the time of the inspection, there were no signs of roof leaks. Recommend monitoring interior walls around and below dormer for any signs of water infiltration. Recommend home owner consider consulting a qualified roofer to evaluate and repair if additional preventive measures are desired.

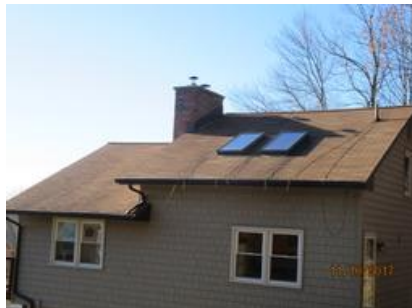
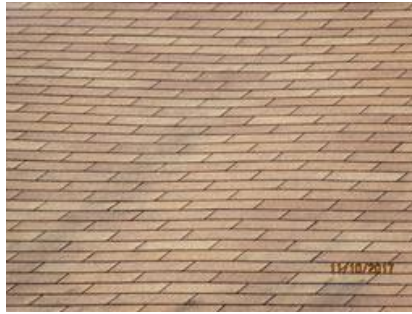
Observed staining on one or more sections of the roof covering. This is likely caused by algae growing on the shingles and is very common. Recommend treatment by a qualified roof cleaner if desired.

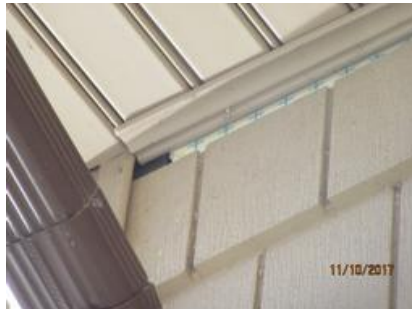
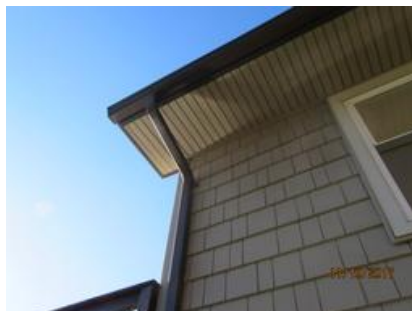
11/11/2017 One section of siding is loose, causing a gap that can allow rain to infiltrate the wall. Siding likely just needs to be popped back into place. Recommend qualified contractor repair.

One section of siding is loose, causing a gap that can allow rain to infiltrate the wall. Siding likely just needs to be popped back into place. Recommend qualified contractor repair.

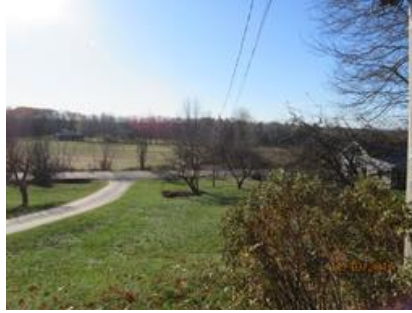
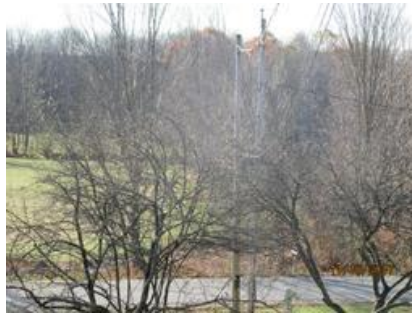
11/11/2017 Cable/Phone lines from pole were threatened by tree overhang. Note: Electrical service lines were not threatened. Recommend having trees trimmed to ensure cables are not pulled on by branches.

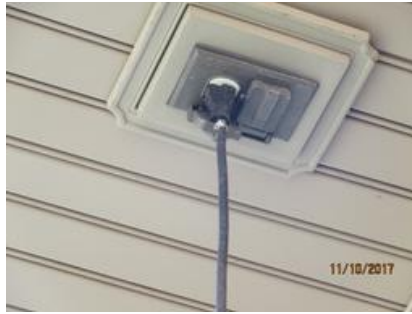
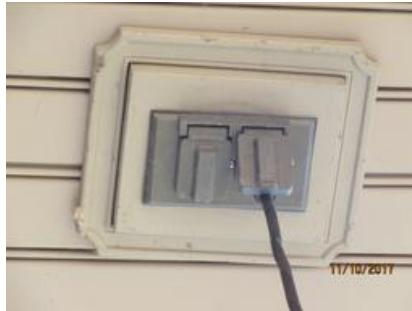
11/11/2017	Unable to verify that the exterior outlets under the eaves were protected by ground fault circuit interrupter (GFCI) devices due to inability to reach the eave height. GFCI devices help prevent electric shocks in areas that may have water present. Recommend having a qualified, licensed electrician verify GFCI protection is in place, and if not repair as needed.
------------	---

11/11/2017 Unable to verify that the exterior outlets under the eaves were protected by ground fault circuit interrupter (GFCI) devices due to inability to reach the eave height. GFCI devices help prevent electric shocks in areas that may have water present. Recommend having a qualified, licensed electrician verify GFCI protection is in place, and if not repair as needed.

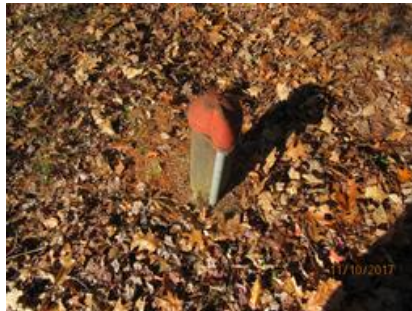
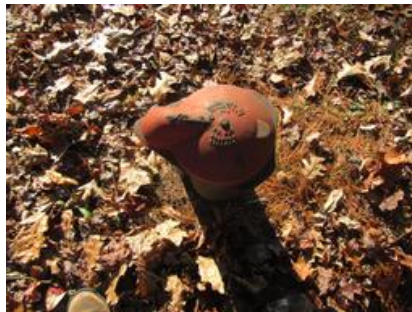
11/11/2017	The well is capped with a non-sanitary type cap. This can all bacteria to enter the well from the surface. Recommend repair by qualified contractor.
------------	--

The well is capped with a non-sanitary type cap. This can all bacteria to enter the well from the surface. Recommend repair by qualified contractor.

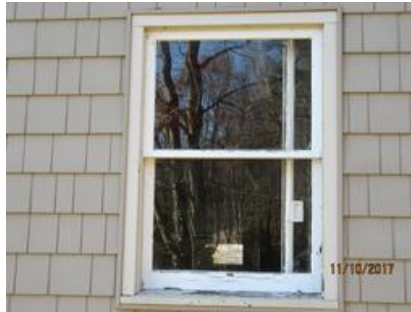
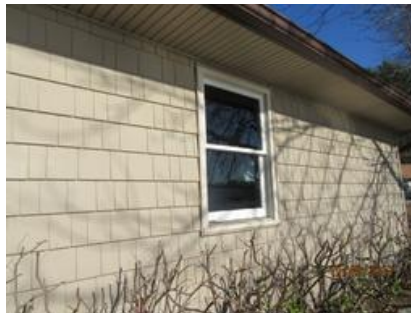
Windows had peeling paint. This can lead to premature weathering and wood rot. Recommend repainting windows.

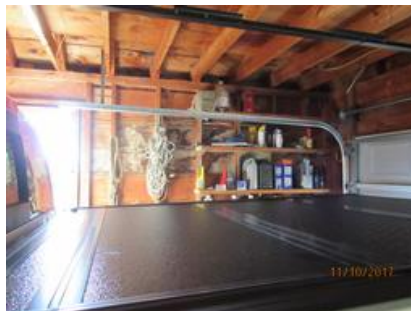
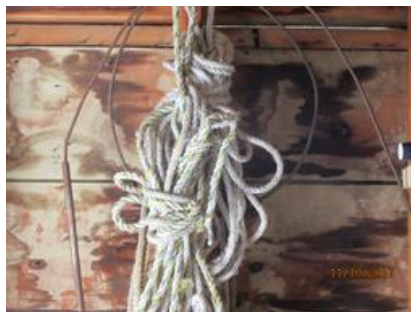
Water stains noted on garage wall. Wall was dry at the time of inspection. Recommend monitoring area to ensure stains are from old leaks.

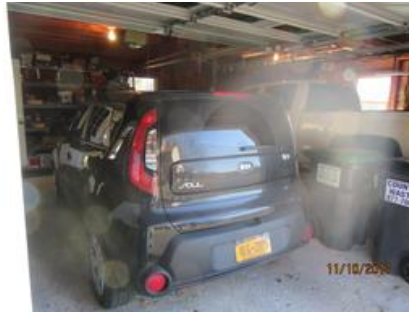
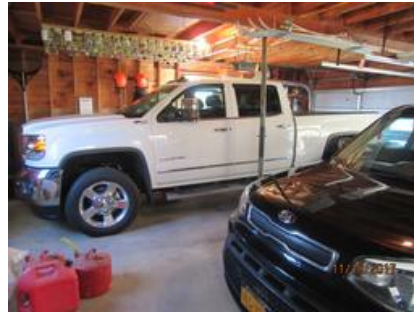
Limited visibility of inside of garage due to parked cars and personal items. Unable to complete a full visual inspection.

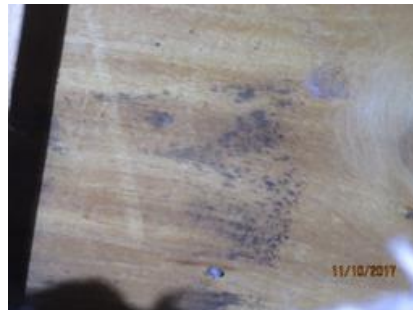
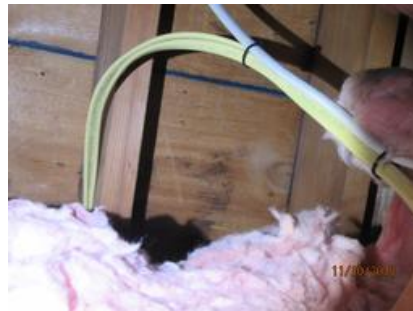
11/11/2017	Mold-like substance observed above the master bedroom attic hatch. Mold in sufficient amounts can create health hazards for some people. Recommend a NYS licensed mold assessor be called to confirm the presence of mold and re-mediate. However, since the effected area is less than 1 sf, the homeowner may also consider treating the area himself with a bleach solution, sanding the wood to remove any mold-like substance, and monitoring the area post treatment.
------------	---

Mold-like substance observed above the master bedroom attic hatch. Mold in sufficient amounts can create health hazards for some people. Recommend a NYS licensed mold assessor be called to confirm the presence of mold and re-mediate. However, since the effected area is less than 1 sf, the homeowner may also consider treating the area himself with a bleach solution, sanding the wood to remove any mold-like substance, and monitoring the area post treatment.

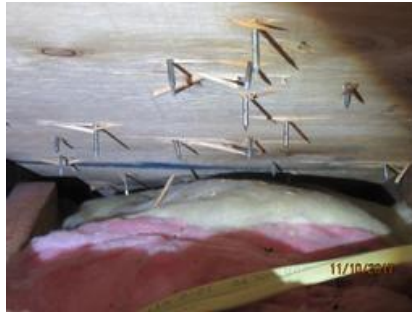
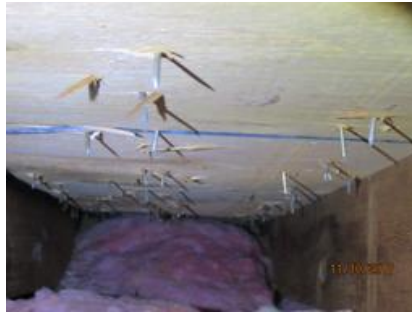
11/11/2017	Insulation was installed into the soffits, blocking the soffit vents. Clearing the soffit vents may improve attic ventilation, which can help prevent moisture buildup and mold growth. Recommend qualified contractor install soffit baffles to ensure air flow through the vents.
------------	---

Insulation was installed into the soffits, blocking the soffit vents. Clearing the soffit vents may improve attic ventilation, which can help prevent moisture buildup and mold growth. Recommend qualified contractor install soffit baffles to ensure air flow through the vents.

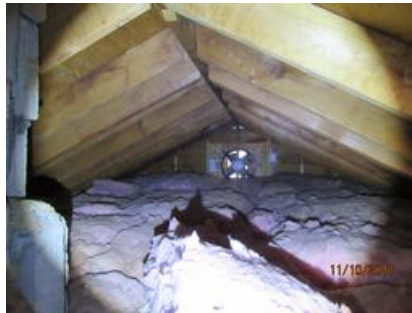
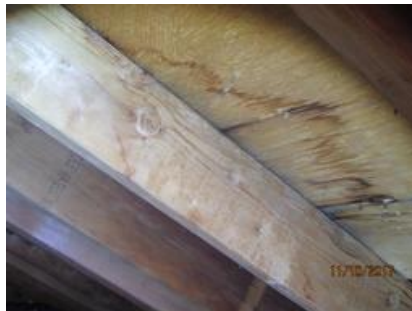
Water stains noted on roof decking. Stains appeared to be dry at time of inspection. No staining of ceiling found below. Stains appeared to be inactive. Recommend monitoring master bedroom ceiling during next rain for any signs of leak just to be sure.

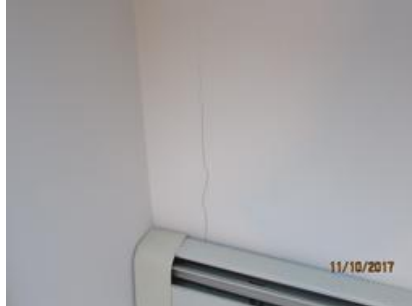
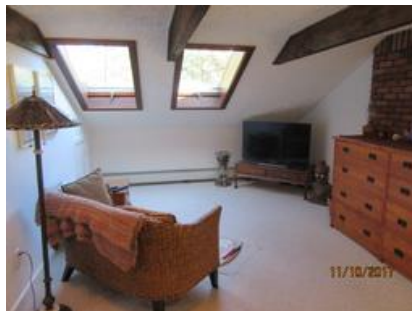
Small crack in drywall. This did not appear to be structural in nature. Recommend repair by qualified contractor if desired for cosmetic reasons.

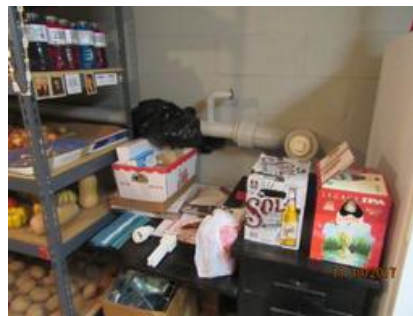
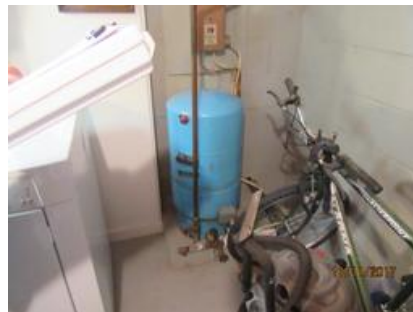
11/11/2017 Well pump was short cycling. While running water continuously, the pump cycled (turned off and then on) in less than 1 minute. This means that the pump needs to run more frequently than normal, which means it could lead to early failure of the well pump. Recommend a qualified well contractor repair as necessary.

Well pump was short cycling. While running water continuously, the pump cycled (turned off and then on) in less than 1 minute. This means that the pump needs to run more frequently than normal, which means it could lead to early failure of the well pump. Recommend a qualified well contractor repair as necessary.

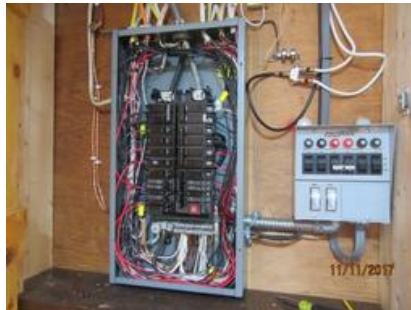
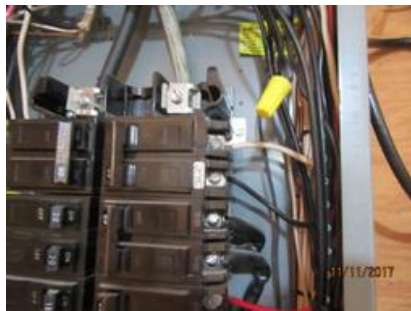
11/11/2017	The electrical panel did not have a single main breaker. The panel was a split bus panel, which used three main breakers to protect the homes circuits. This is a safety issue, because in an emergency, it is not clear that three breakers need to be flipped to order to turn off power to the home. While this is technically not a defect, this condition may be considered less safe than having one main disconnect switch. The use of split bus panels was phased out in the 1980's. Recommend repair by qualified contractor.
------------	--

The electrical panel did not have a single main breaker. The panel was a split bus panel, which used three main breakers to protect the homes circuits. This is a safety issue, because in an emergency, it is not clear that three breakers need to be flipped to order to turn off power to the home. While this is technically not a defect, this condition may be considered less safe than having one main disconnect switch. The use of split bus panels was phased out in the 1980's. Recommend repair by qualified contractor.

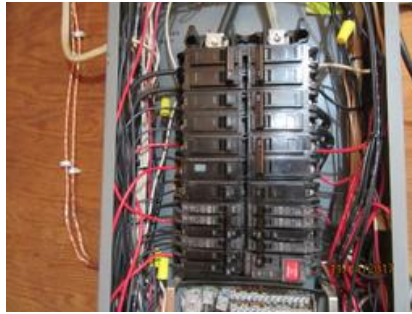
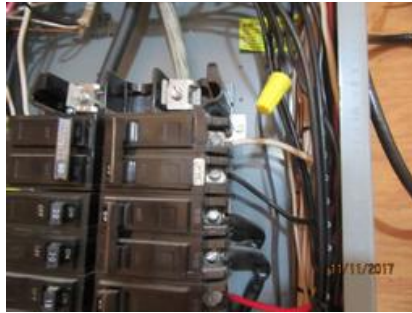
11/11/2017	The electrical panel was wired with a 20 Amp breaker servicing a 14 gauge circuit. A 60 Amp breaker was used to service a 12 gauge circuit. Because the wires are rated for less power than what the breakers are rated for, the breakers can fail to trip, making the wires overheat and possibly cause a fire. Recommend qualified contractor repair as soon as possible.
------------	---

The electrical panel was wired with a 20 Amp breaker servicing a 14 gauge circuit. A 60 Amp breaker was used to service a 12 gauge circuit. Because the wires are rated for less power than what the breakers are rated for, the breakers can fail to trip, making the wires overheat and possibly cause a fire. Recommend qualified contractor repair as soon as possible.

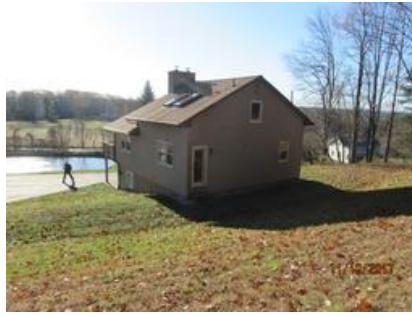
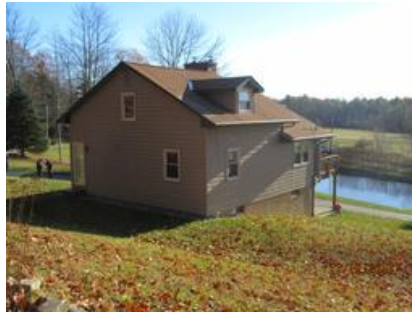
No evidence observed for existence of wood damage or wood destroying insect infestation. Note: The grade in the rear of the home allowed very little foundation exposure. Due to the proximity to the ground, the area along the rear sill plate is the most likely entry point on this home for most wood destroying insects. If the home owner is interested in monitoring the home for insect activity, this area would be the best place to monitor.
