Home Inspection Report

Client: Jane Doe
Property: 1945 Inspection Way Home Town NY 12306
Email: janeedoe1111@gmail.com
Inspection Date: 8/28/18

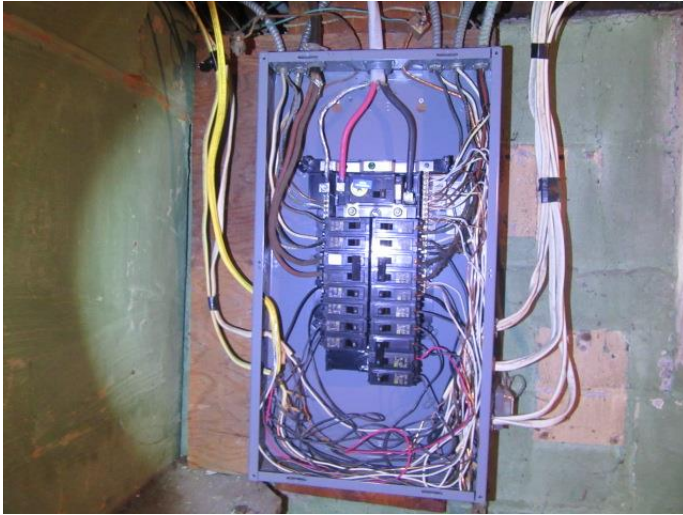
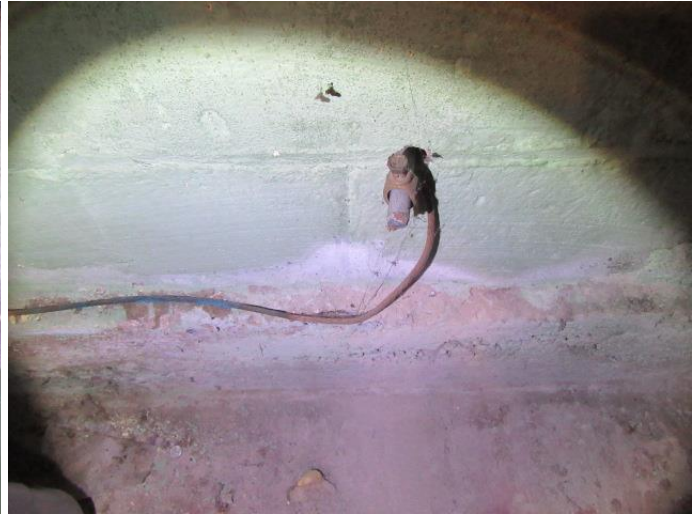
General Pictures of the Electrical System. No significant defects observed at the time of the inspection.

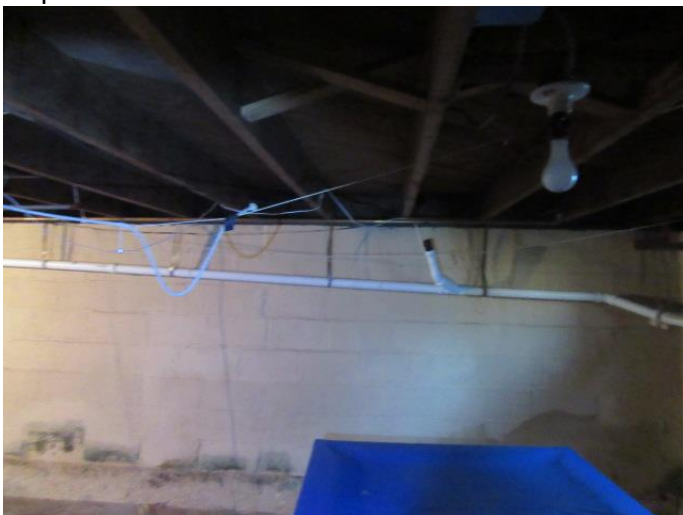
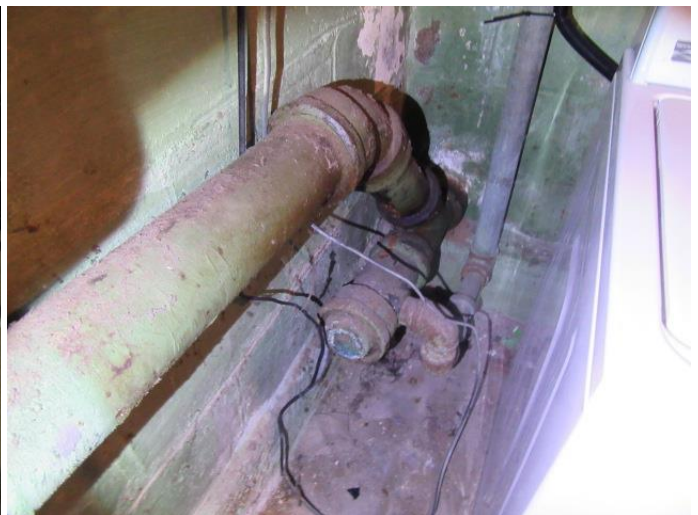
General Pictures of the Plumbing System. No significant defects observed at the time of the inspection. No leaks were detected.
