## Client

Jane Doe  
1945 Inspection Way  
Home Town, 12345  
HIN™: 123451304  
Email:  
Inspection Date: 10-14-2017

## Inspector

TriCheck Home Inspections LLC  
Bob Patton  
24 Oxford Circle  
Troy, New York 12180  
Phone: (518) 961-2522  
E-Mail: [trichheckinspections@gmail.com](mailto:trichheckinspections@gmail.com)

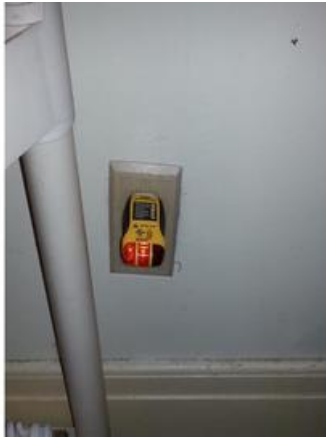
10/15/2017	Three prong outlet in Bedroom was tested and polarity was reversed. This can cause a shock hazard under certain circumstances. Recommend qualified electrician repair.
------------	--

Three prong outlet in Bedroom was tested and polarity was reversed. This can cause a shock hazard under certain circumstances. Recommend qualified electrician repair.

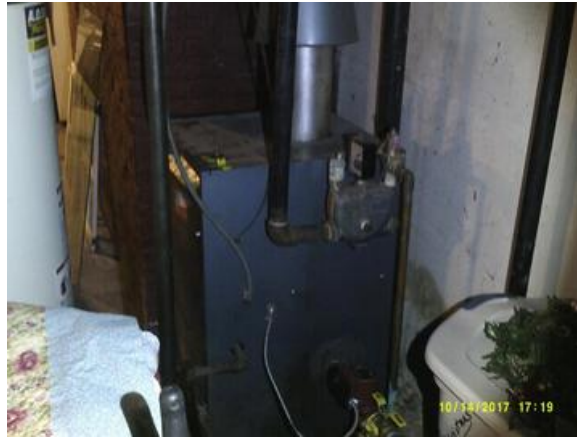
11/24/2017 Picture of Furnace

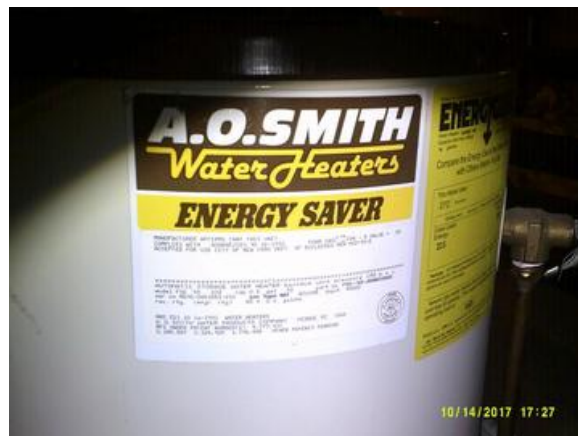
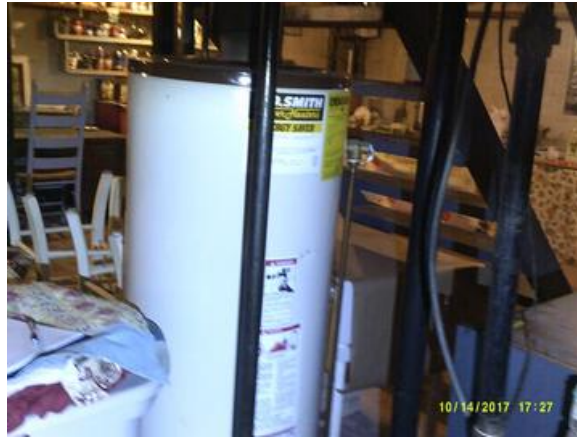
10/15/2017 Pictures of Hot Water Heater
